FINAL
Documentation & Salvage Report
58-60 Ellen Street East & 115 Lancaster Street East
City of Kitchener
Region of Waterloo
Lot 3, German Company Tract
Geographic Township of Waterloo
Former Waterloo County

HR-517-2024
Project #: 2023-0269/2023-0269

2024-10-01

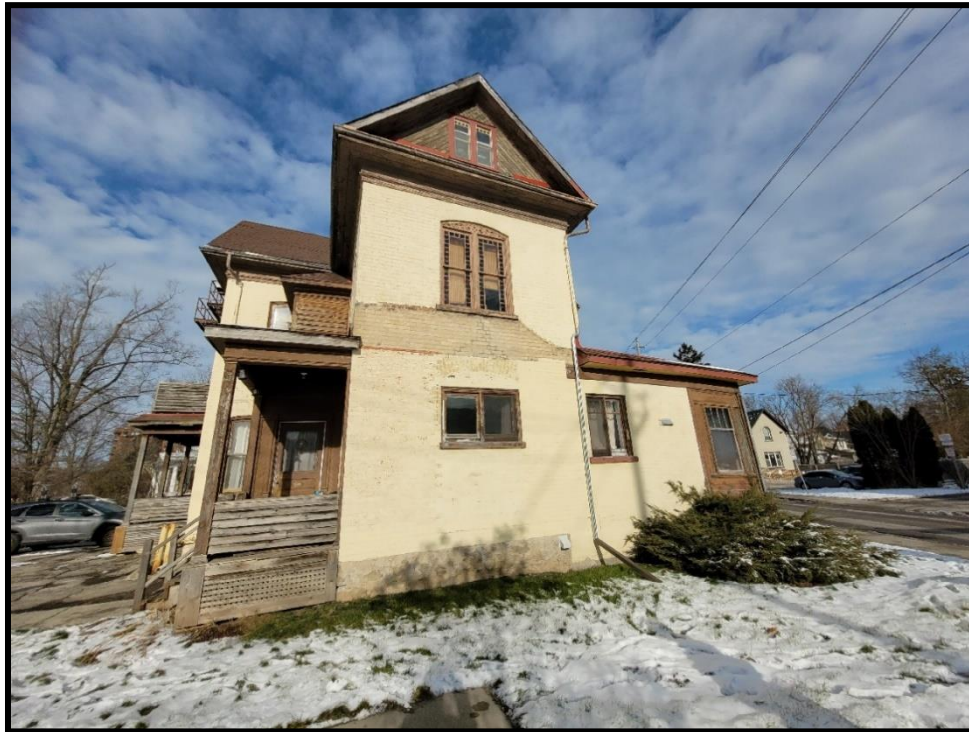
The multi-unit residence is a three-bay, two-and-a-half storey structure built circa 1888. The structure rests on a stone foundation, has an intersecting gable roof clad in asphalt shingles and is constructed of brick that has been painted (see Image 7). The building's Greek cross floor plan

Image 7: Subject Property – Façade
(Photo taken December 20, 2021; Facing North)

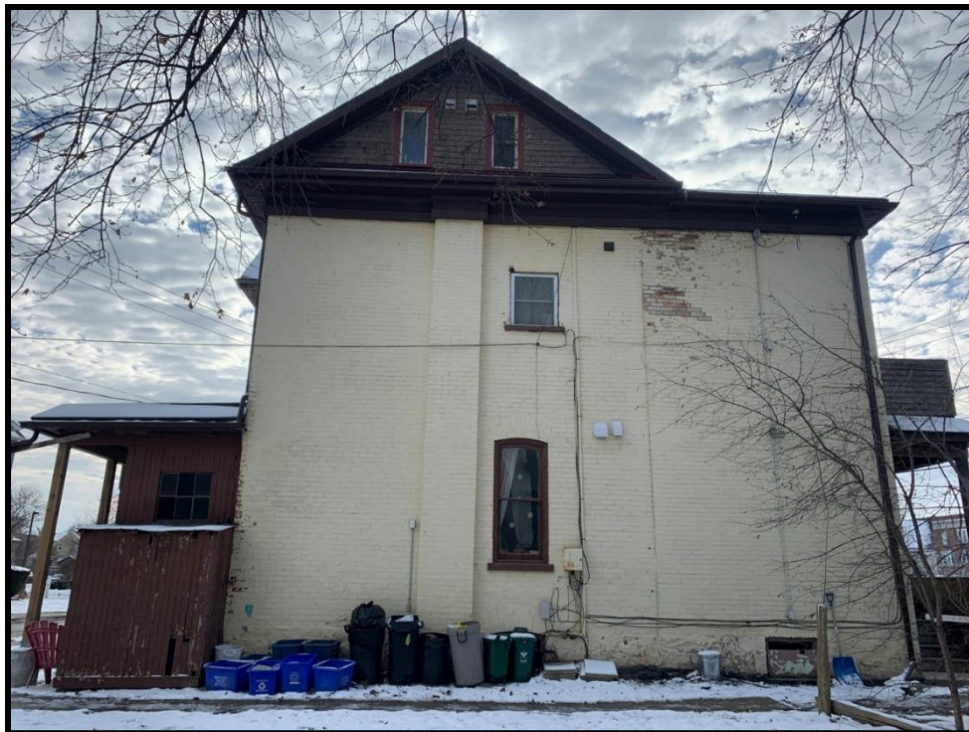
The rear (northwest) elevation contains fewer openings than the façade and side elevations (see Image 30). The one-storey addition on the north corner contains one window opening on this elevation and contains a six-paned fixed wooden window (see Image 31). Brick discoloration on the residence's north corner and lumber deterioration on the one-storey addition suggest water is not being adequately shed (see Image 32). The northwest elevation contains an outside chimney placed at the centre of the gable end (see Image 33). The gable end on this elevation is clad in rectangular shingles and the two attic window openings contain vinyl sash windows (see Image 34). The wooden soffit and molded frieze have been clad in aluminum flashing on this elevation. The two-storey addition on the west corner of the residence is distinguished by a change in the roofline as well as some discolouration at the intersection of the addition and residence masonry (see Image 35). A portion of the brick masonry has been replaced and repointed along this intersecting line (see Image 36). The addition appears to use similar construction methods as the initial residence, with brick laid in a stretcher pattern and built on a stone foundation (see Image 37). A single header course laid on the stone foundation is seen on both the two-storey addition and the residence (see Image 38). A key difference between the finishes on the two-storey addition and the residence is the framing of the openings, with segmental arches framing the residence's openings and flat or jack arches framing the openings on the two storey addition (see Image 39 and Image 40).

Image 30: Subject Property – Northwest Elevation
(Photo taken December 20, 2021; Facing South)

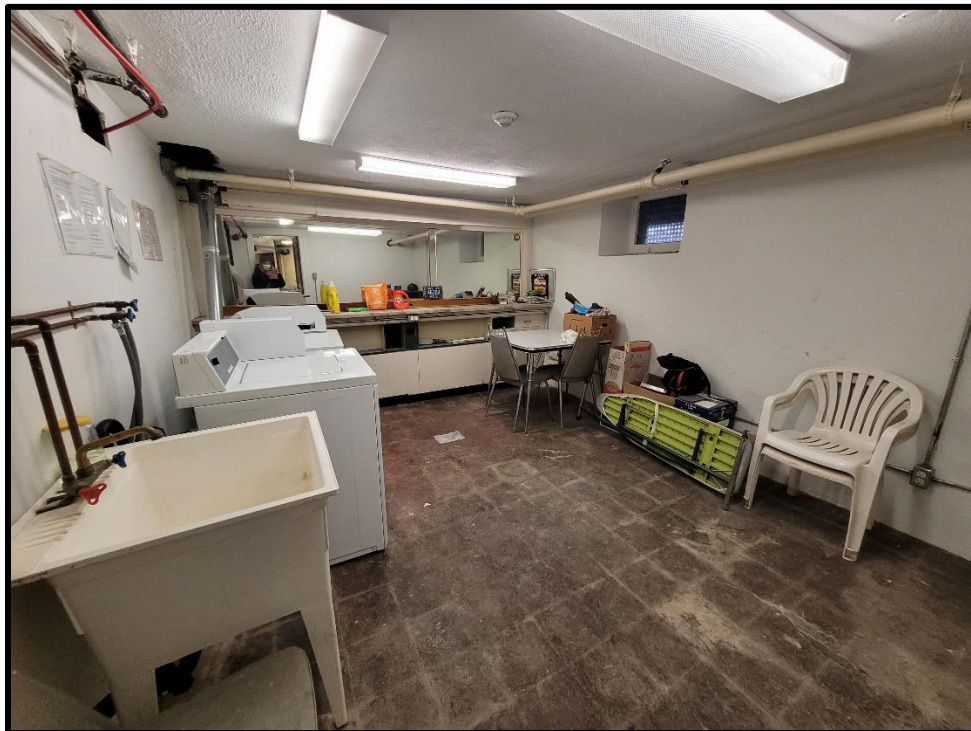
Image 90: Basement – Former Barbershop Space
(Photo taken December 20, 2021)

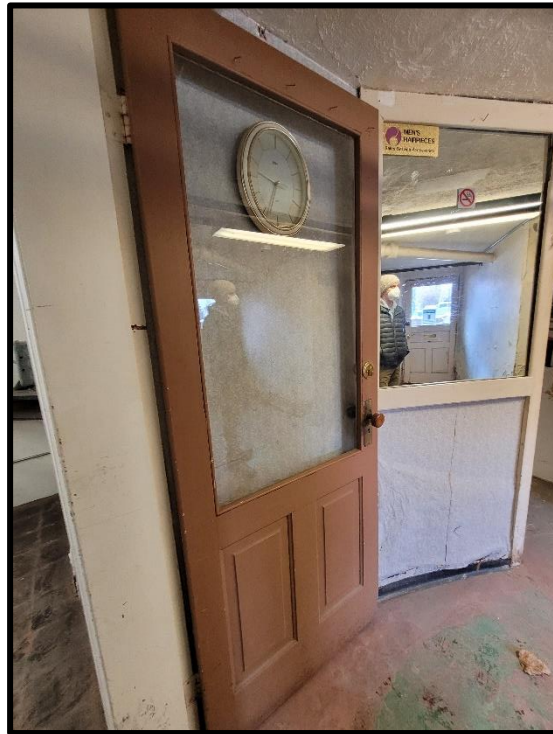
Image 91: Basement – Wooden Paneled Door
(Photo taken December 20, 2021)
