60 Victoria Street North, Kitchener

Heritage Conservation Plan

60 Victoria Street North, Kitchener, ON

February 28, 2025

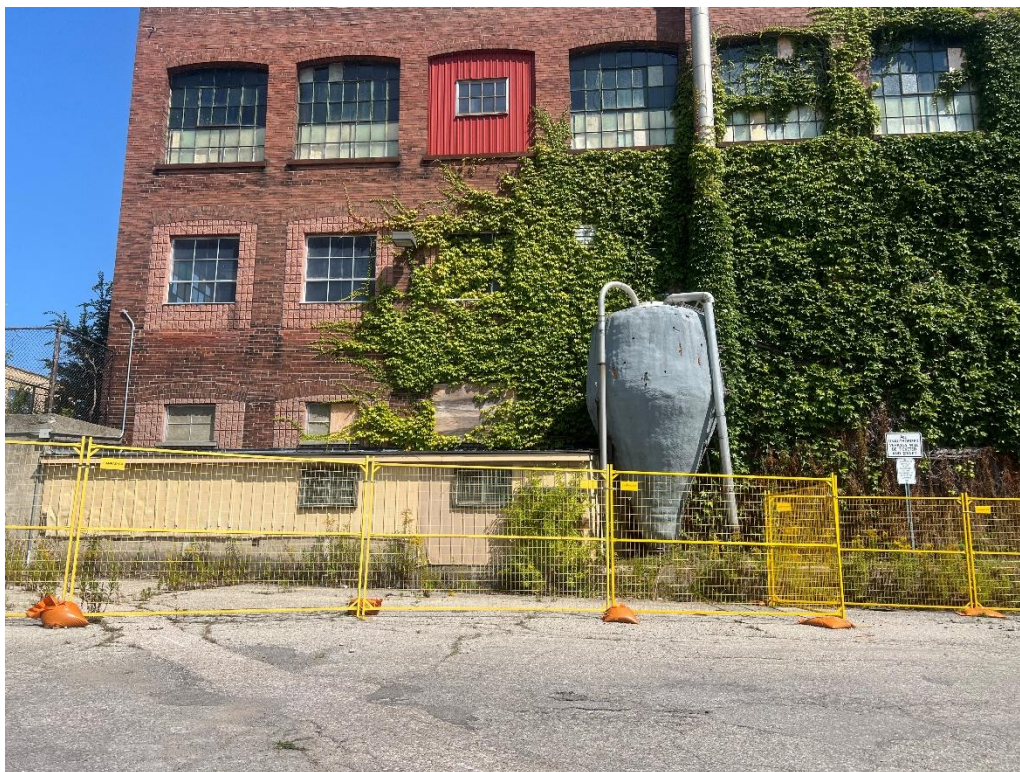
Photograph No. 7 – Overview of Non-matching Split Face Architectural Block and Red Sheet Metal Cladding Window Infills

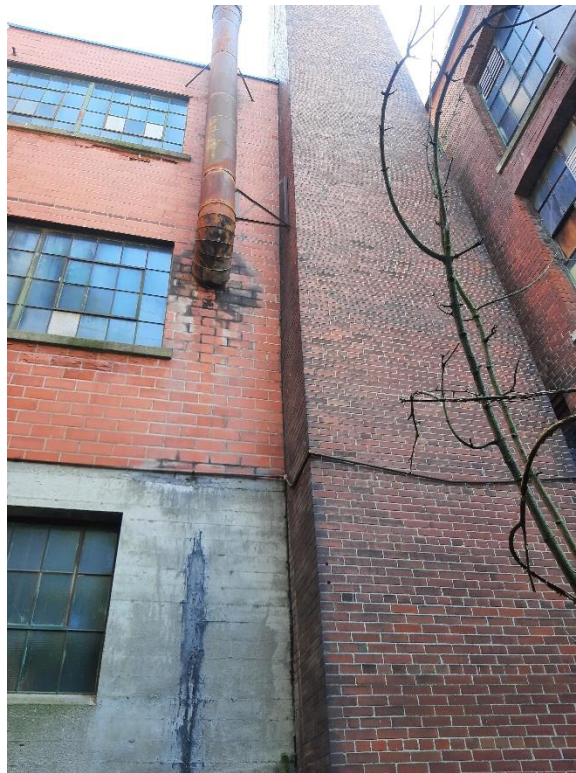
Photograph No. 9 –Chimney to Be Demolished and Brick Salvaged for Reuse

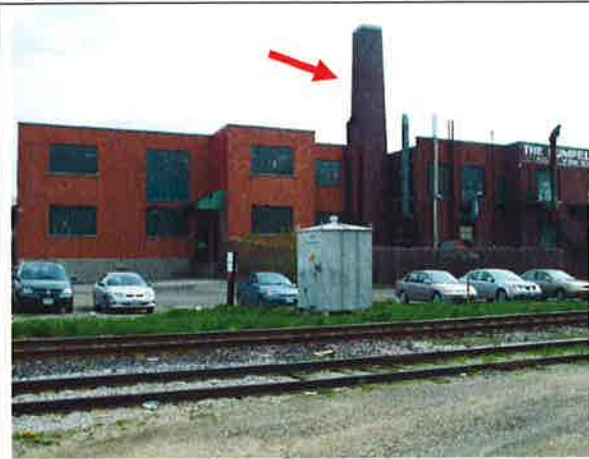
Picture 6: Chimney

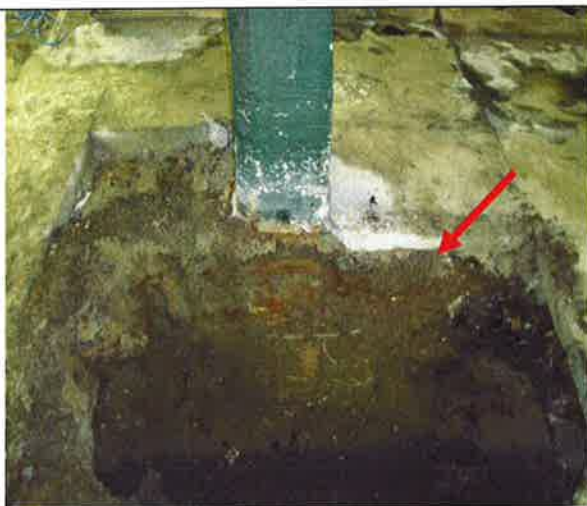
Picture 9

As there was no design information available for the 1913 building we employed a contractor to excavate down to the existing footings at 5 locations to determine the footing size as well as provide opportunity for LVM Geotechnical Engineers to assess the soil capacity. Excavations were made to reveal three (3) interior footings, which were measured to be tapered piers approximately 48" square x 46" tall (see Picture 9). However, assuming a soil bearing capacity of 3000psf this footing size is insufficient to support the gravity load of the building. This leads us to believe there may be deeper foundations units such as caissons or piles of greater capacity supporting the piers that we were unable to detect and measure at the time of excavation. LVM determined through test pits and boreholes that fill, unsuitable for bearing, exists at and below these footings which could also suggest that caissons or piles may be present.

Excavation at existing column base to investigate the column footing in the 1913 portion of the building

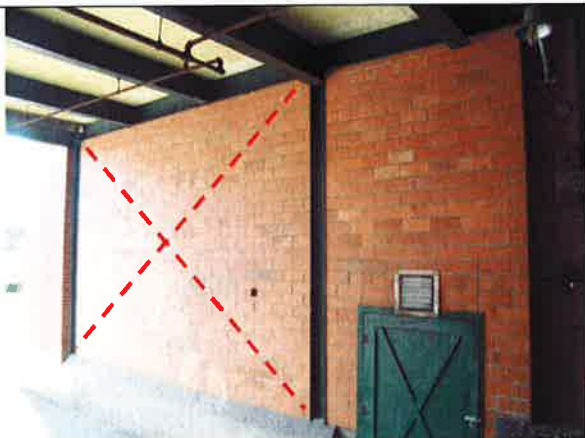
Picture 18

The drawings for the 1968 building addition indicate a steel braced frame introduced for this addition adjacent to the adjoining east wall of the 1913 building. We were unable to confirm the presence of this bracing as there is masonry or other finishes covering this area (see Picture 18). We have checked the design loads labeled on this "wind" brace (as it is called on the drawings) and it does not have sufficient capacity to meet the current seismic design forces.

Exposed steel framing at the building south entrance from Victoria St.

Steel braced frame location as shown in 1968 drawings, possibly hidden by brick

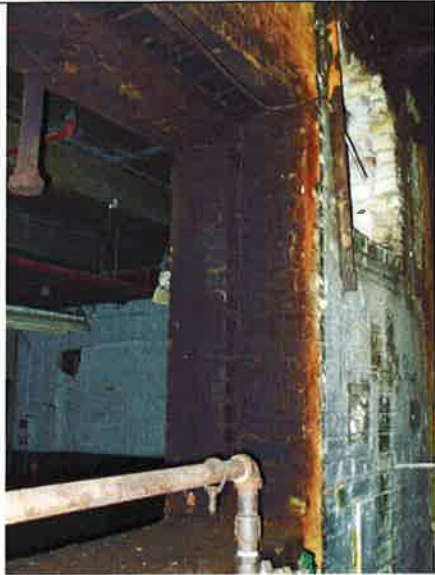
Picture 21

Some cracks were observed in the brick masonry (see Picture 13). In addition bricks were cut and/or removed to make passages for doorways and ducts (See Picture 21). Generally the building masonry appears to be in good condition without significant signs of structural distress.

Holes made through masonry 1942 addition

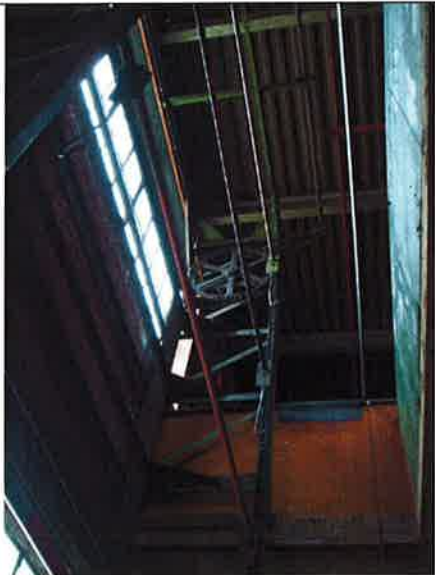
Picture 22

The elevator in the 1913 building area was inoperable and inaccessible and as such we did not review the applicable structure or pit for its suitability for reuse. A second mechanical lift is located within the 1962 addition on the east wall, serving all three floors (see Picture 22). Review of this mechanical lift system was not part of our scope. The present opening through the floors could possibly be used for stairs.

Opening through floors for mechanical lift
1962 addition, east wall.

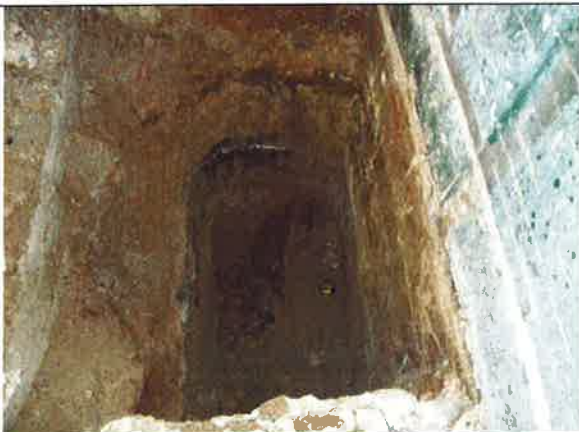
Picture 23

Excavations at two other locations in the 1913 building were made to uncover (from one side) strip footings supporting the masonry walls. Based on the projection of the footing beyond the wall and the masonry wall thickness we estimate the strip footing to be approximately 42" wide x 12" thick (see Picture 23). Again, no caissons were observed in the excavation.

Strip footing under interior masonry wall
(east wall, 1913 building)

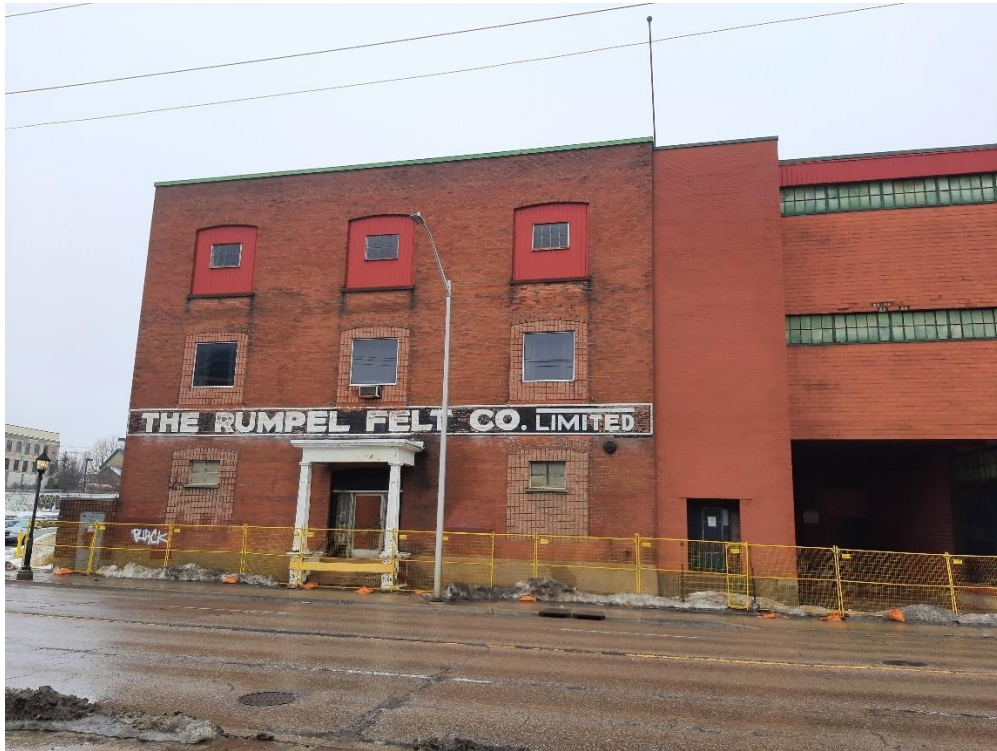
1. The masonry is generally in good condition with limited cracks and mortar deterioration. Newer brick has been added to infill window areas, in satisfactory condition. (Photograph 1).

Photograph No. 1 – South Façade

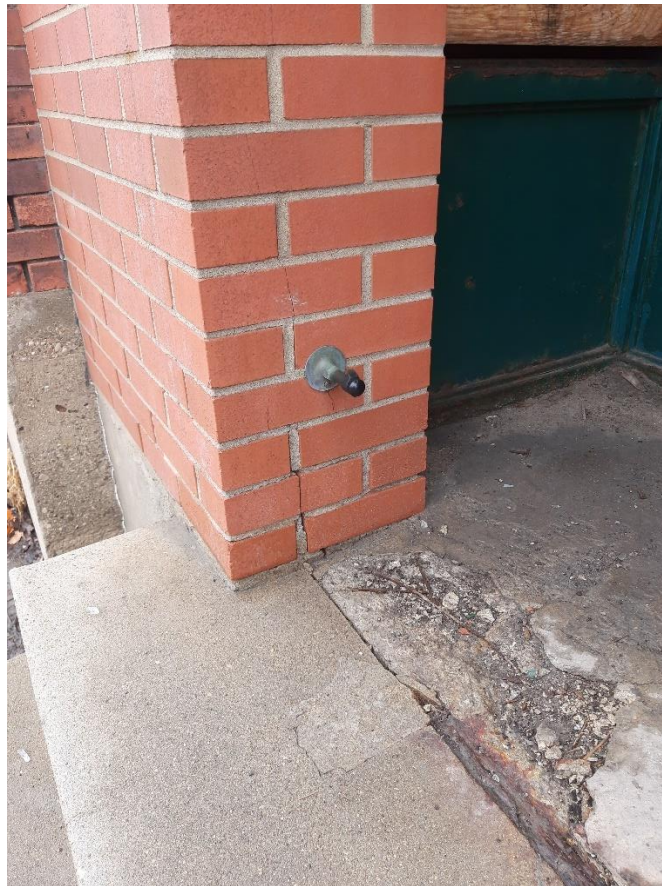
2. East Entrance (Victoria St) - Concrete steps and landing slab badly cracked, heaved (door has trouble opening). Recommend repair, and/or partial reconstruction. (Photograph 2). Hollow metal door is badly corroded (non structural, recommend replacement).

Photograph No. 2 – Right Entrance Floor Slab Deterioration

4. Repoint all brick mortar deterioration. Monitor thru brick cracks or replace brick (Photograph 2).
 5. Infill all masonry holes and openings, toothing in to match existing courses. (e.g. Photographs 22,23).

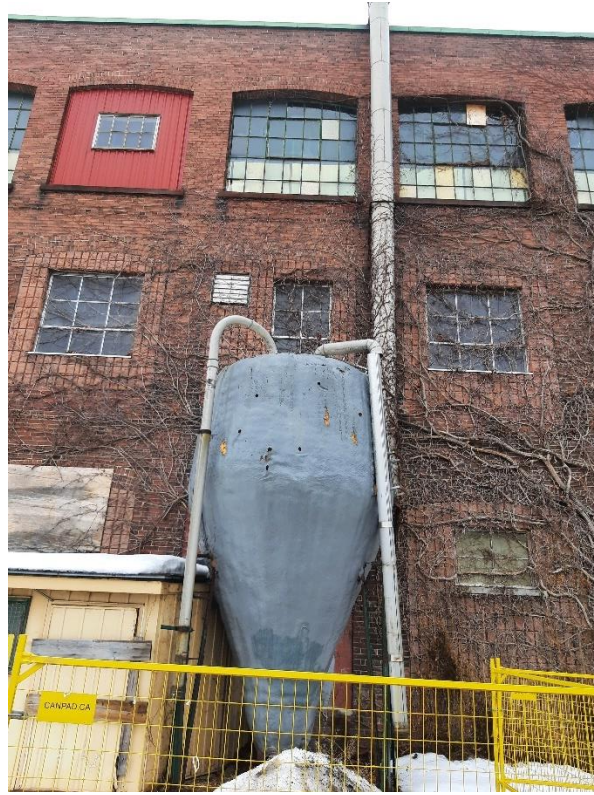
Photograph No. 5 – Salt Storage Delivery System

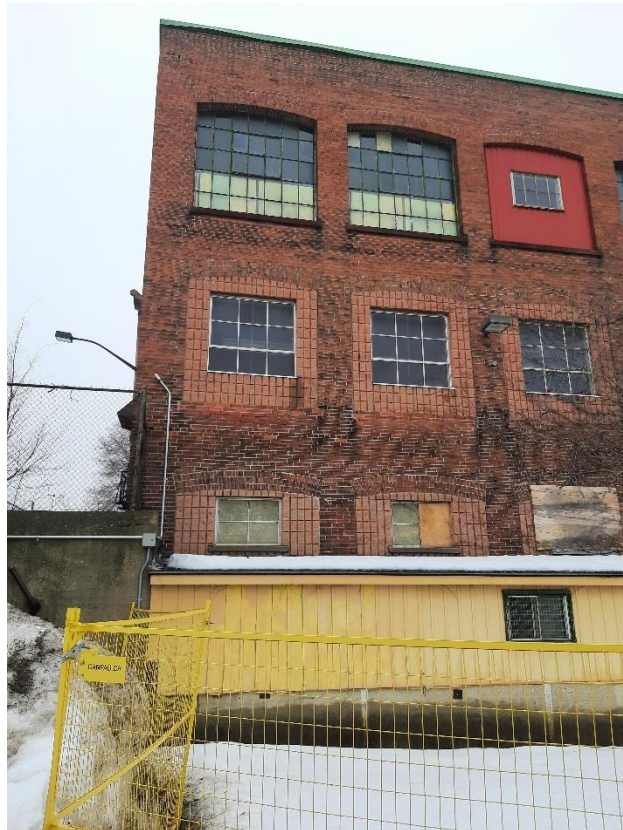
Photograph No. 6 – West Shed Addition

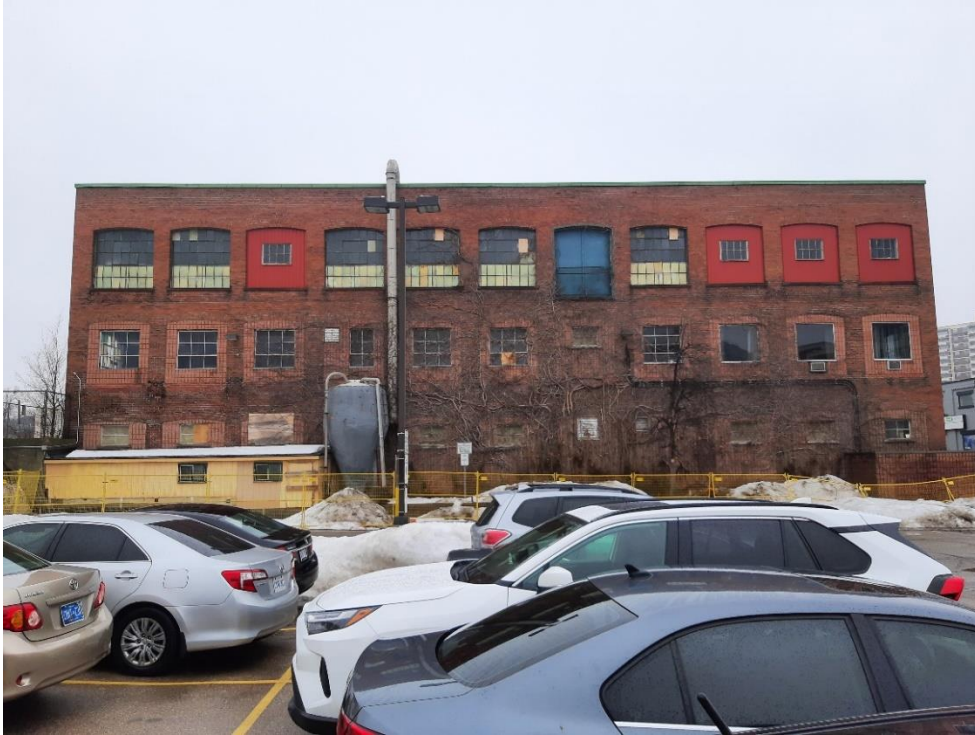
4. Brick mortar has deteriorated in areas; brick veneer cracked at entrance (Photograph 4).
5. Vines growing on the west wall hold moisture and are a threat to the long term durability of the brick and should be removed. (Photograph 7).

Photograph No. 7 – West Elevation

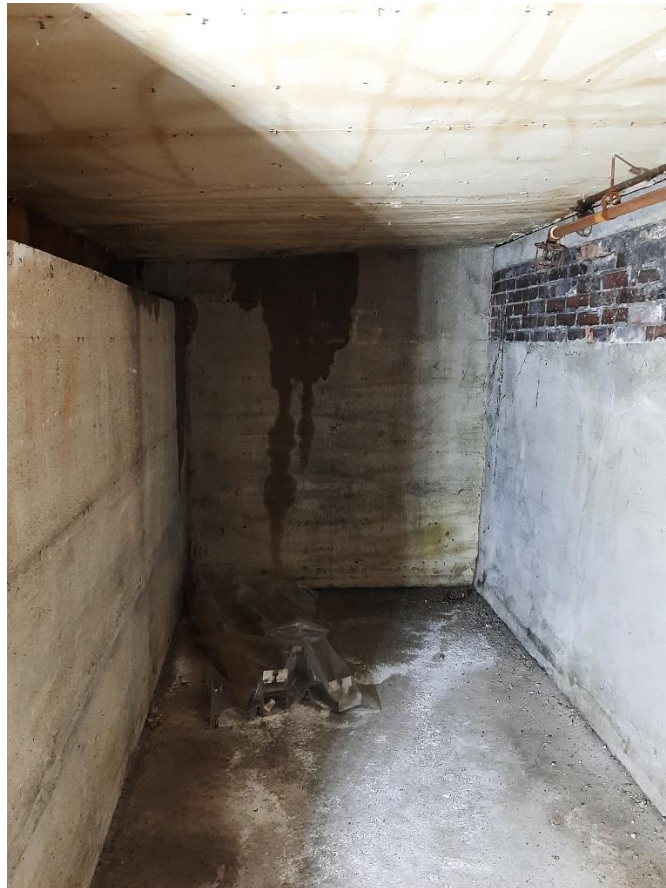
6. Window caulking worn/brittle; needs to be replaced/redone.
7. West shed was an addition; see door through blocked up window (Photographs 7-10).
8. Very few cracks in masonry; some windowpanes missing or cracked. (Photographs 11-13). Evidence of step cracking and repointing of mortar (Photograph 13).

Photograph No. 8 – West Shed Addition, to be Removed

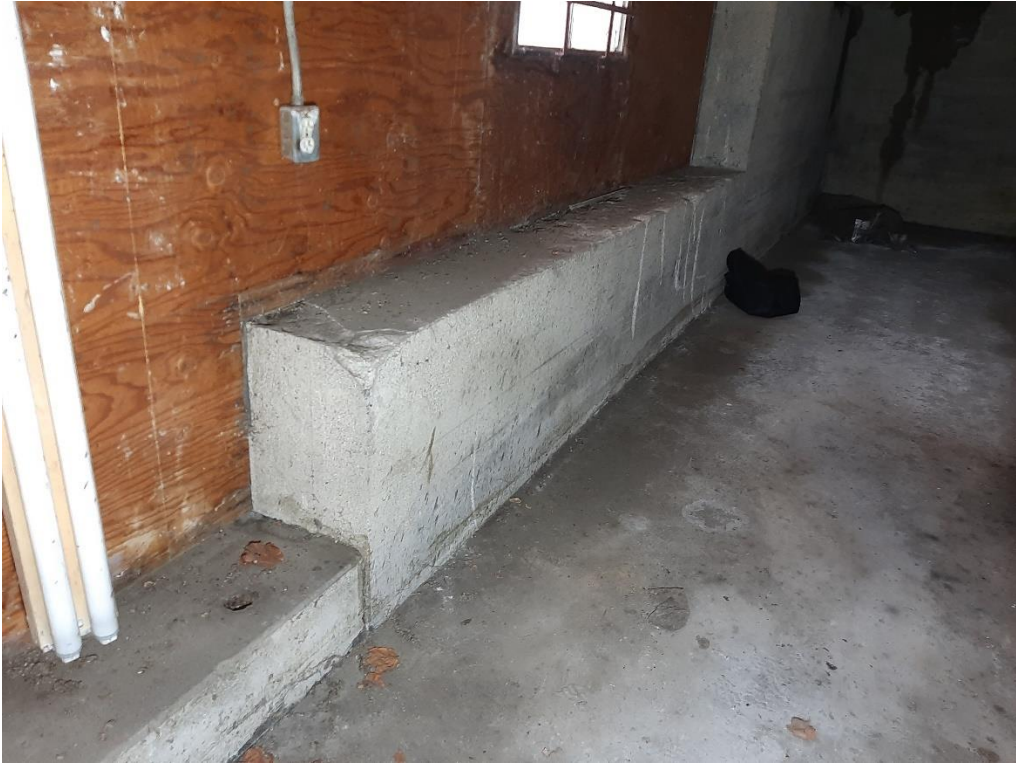
Photograph No. 9 – West Shed Addition Foundations, to be Removed

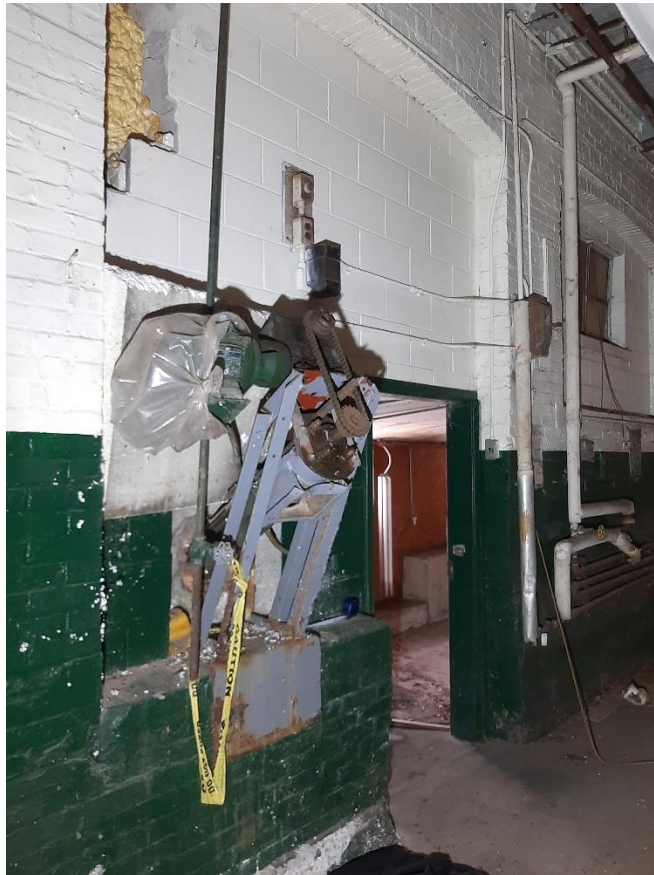
Photograph No. 10 – West Shed Entrance Within Former Window

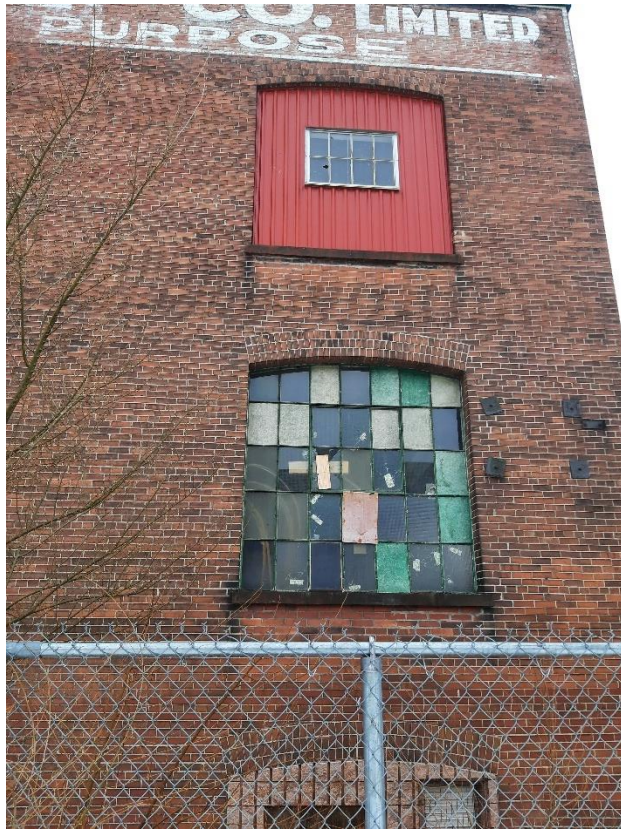
Photograph No. 11 – North Elevation - West Corner

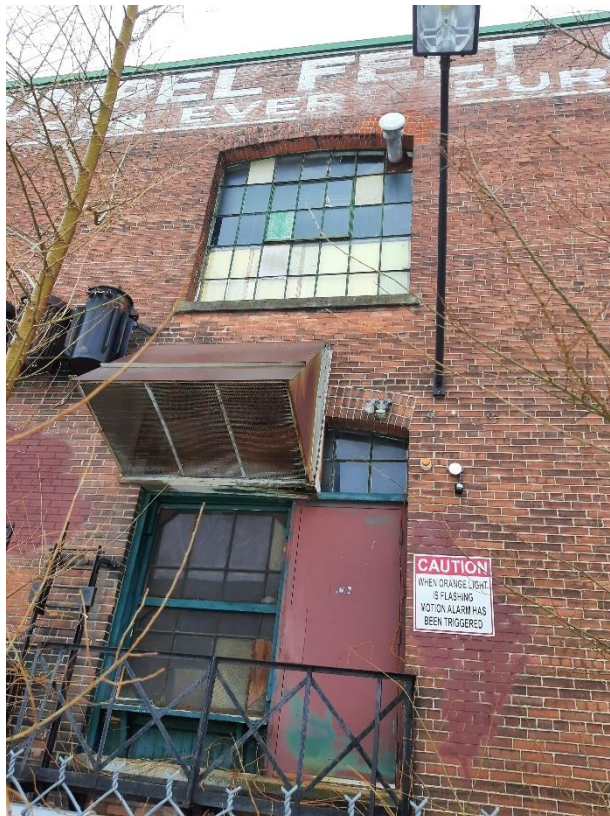
Photograph No. 12 – North Elevation - Middle

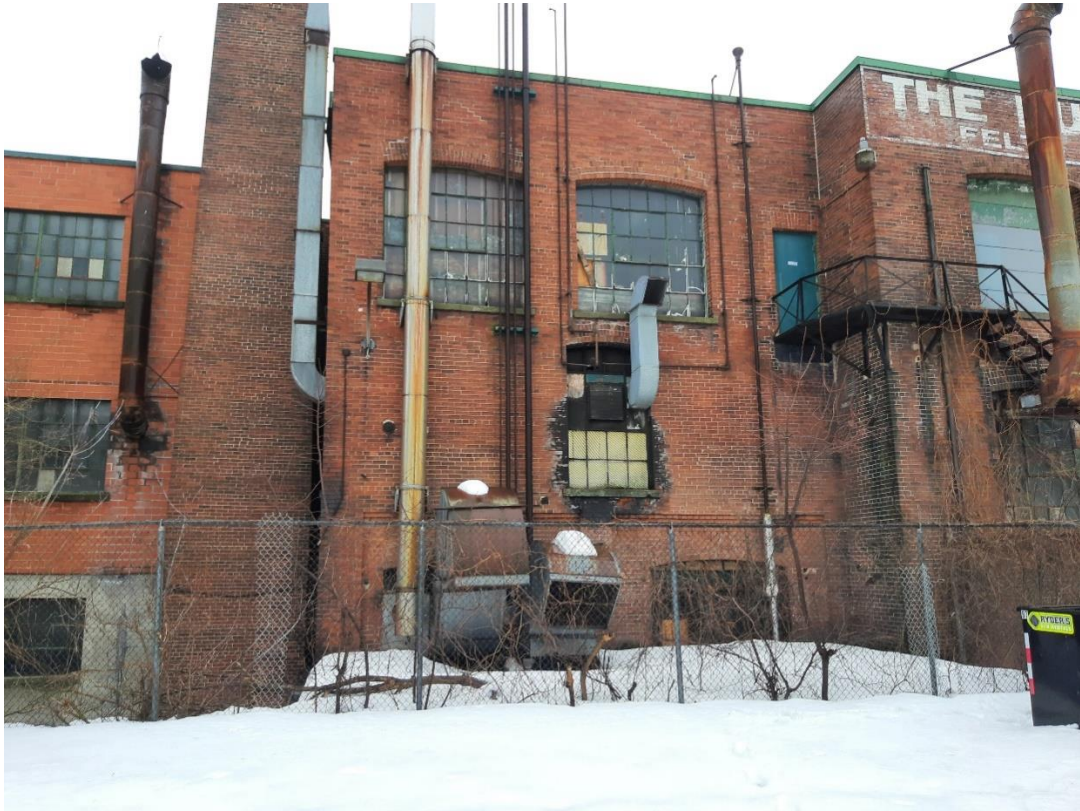
Photograph No. 13 – North Elevation - East Corner

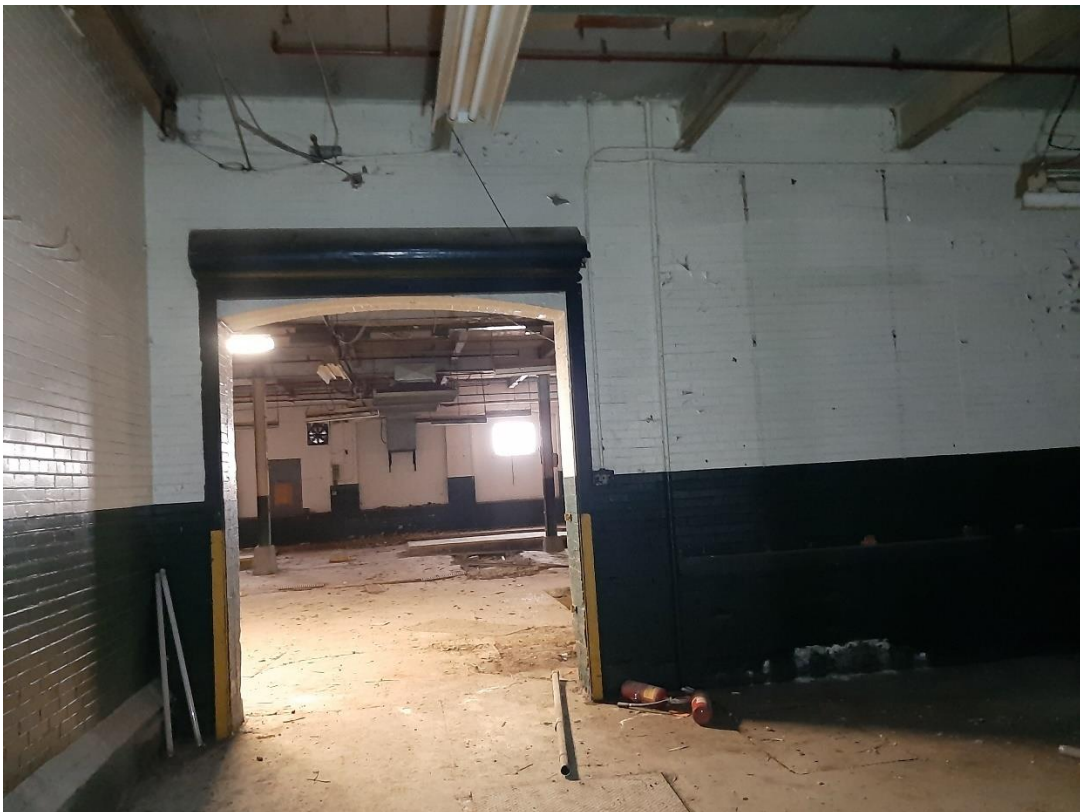
Photograph No. 14 – Ground Floor Door to be infilled

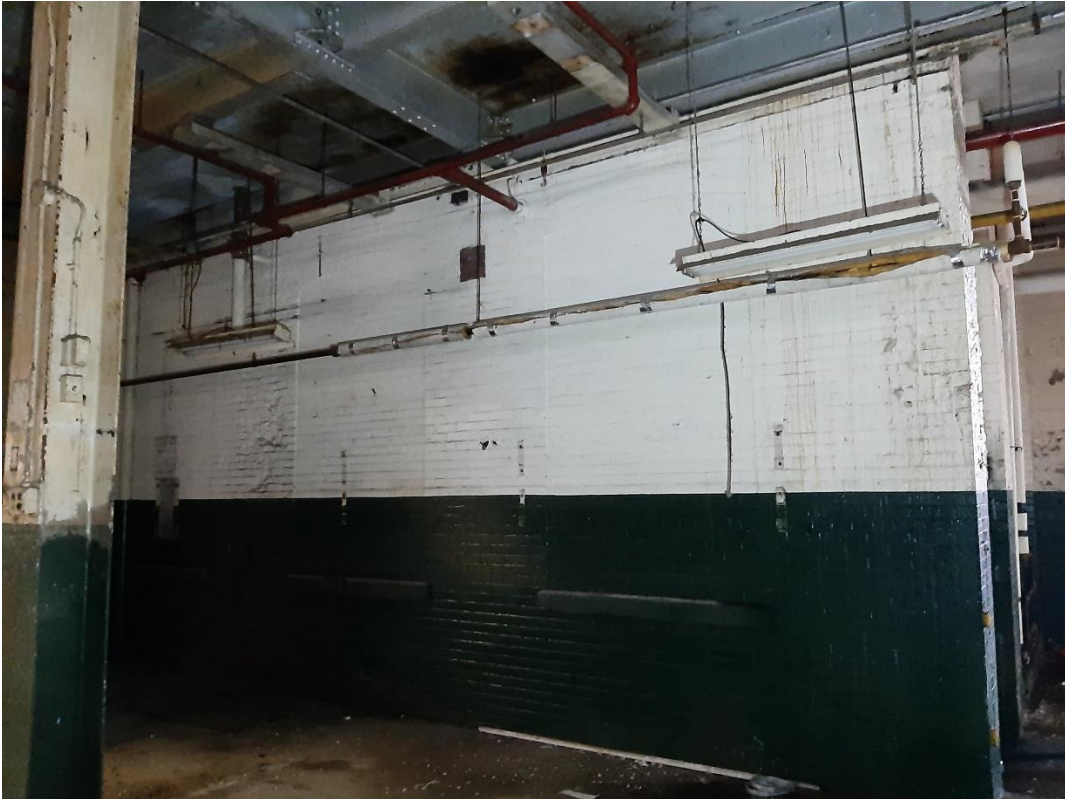
Photograph No. 17 – Ground Floor - Looking North

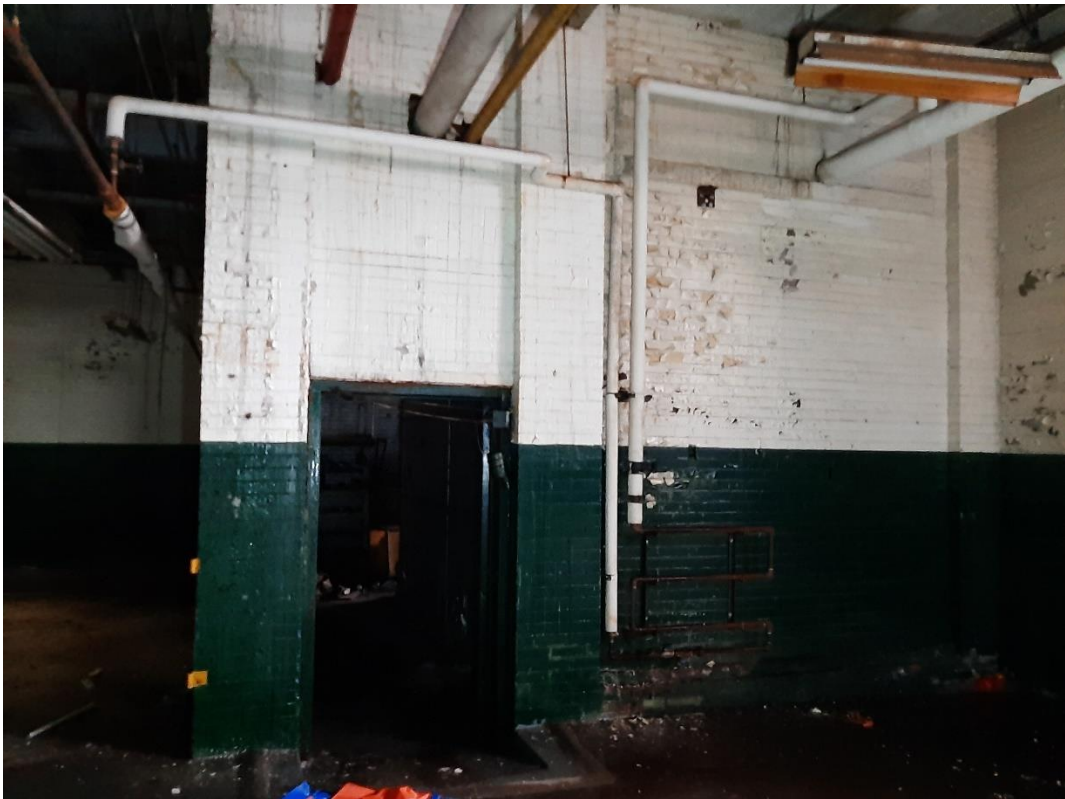
Photograph No. 18 – Ground Floor - Looking West

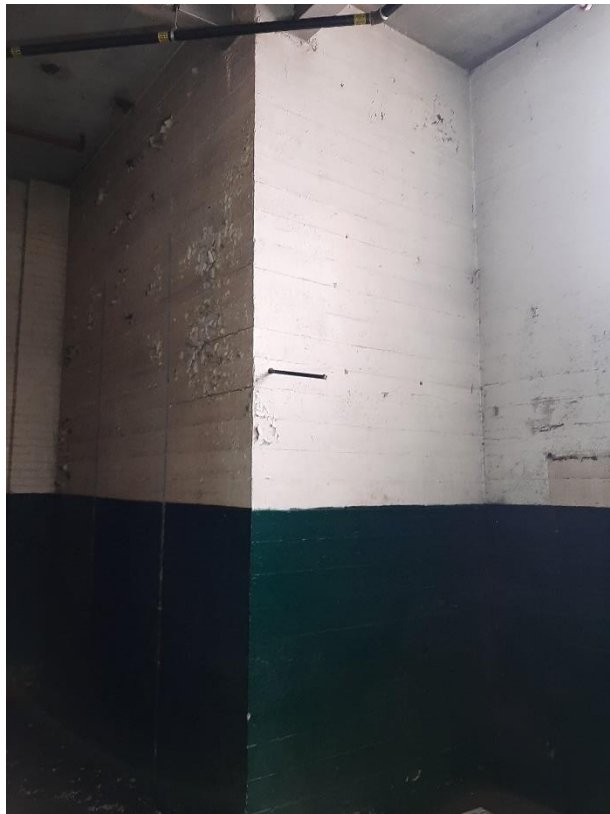
Photograph No. 20 – Ground Floor - Wall Wrapping Chimney

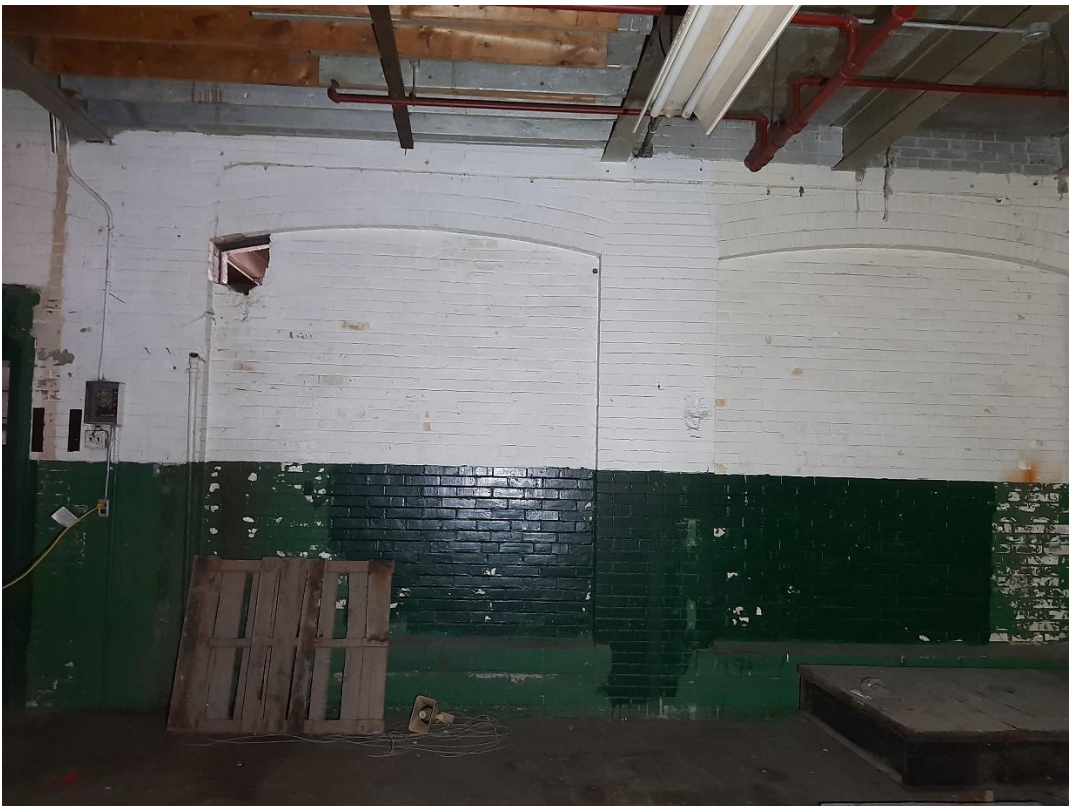
9. Painted brick masonry is generally in good condition; interior sheltered by additions (Photographs 13-31).; some openings through brick will need to be infilled with reclaimed brick from the Chimney (Photographs 22,23).

Photograph No. 22 – Second Floor Wall

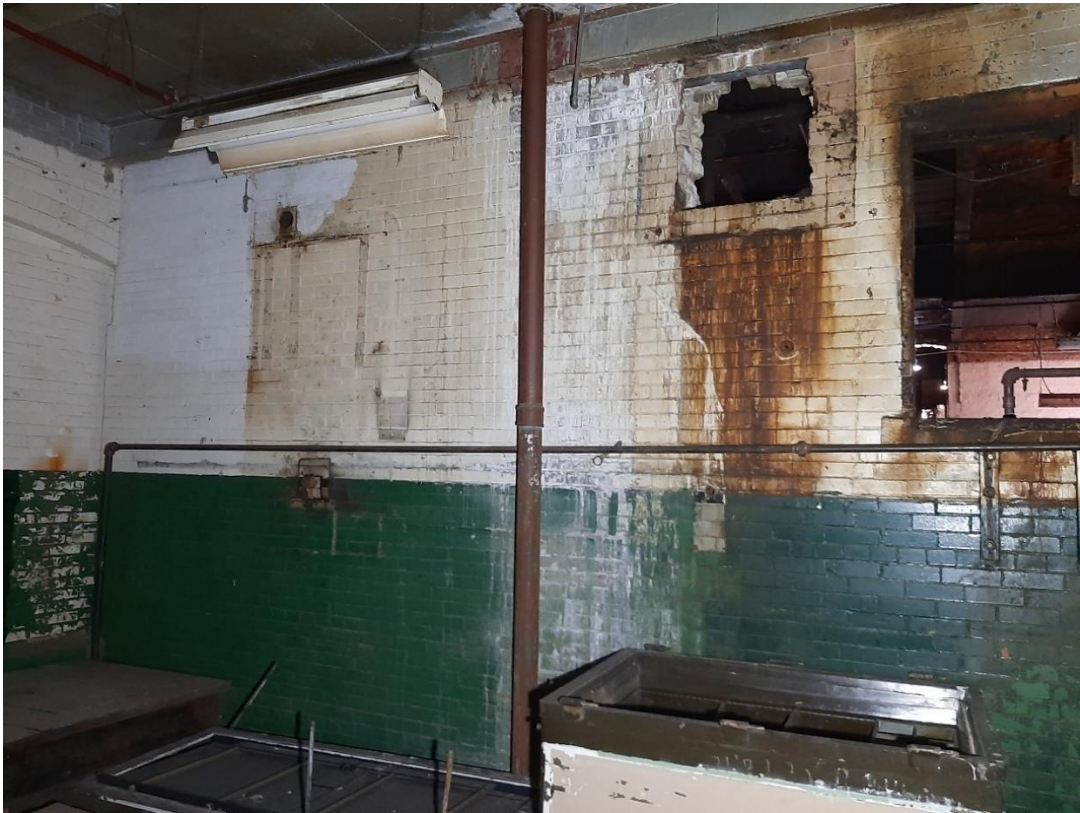
Photograph No. 23 – Second Floor - Looking North

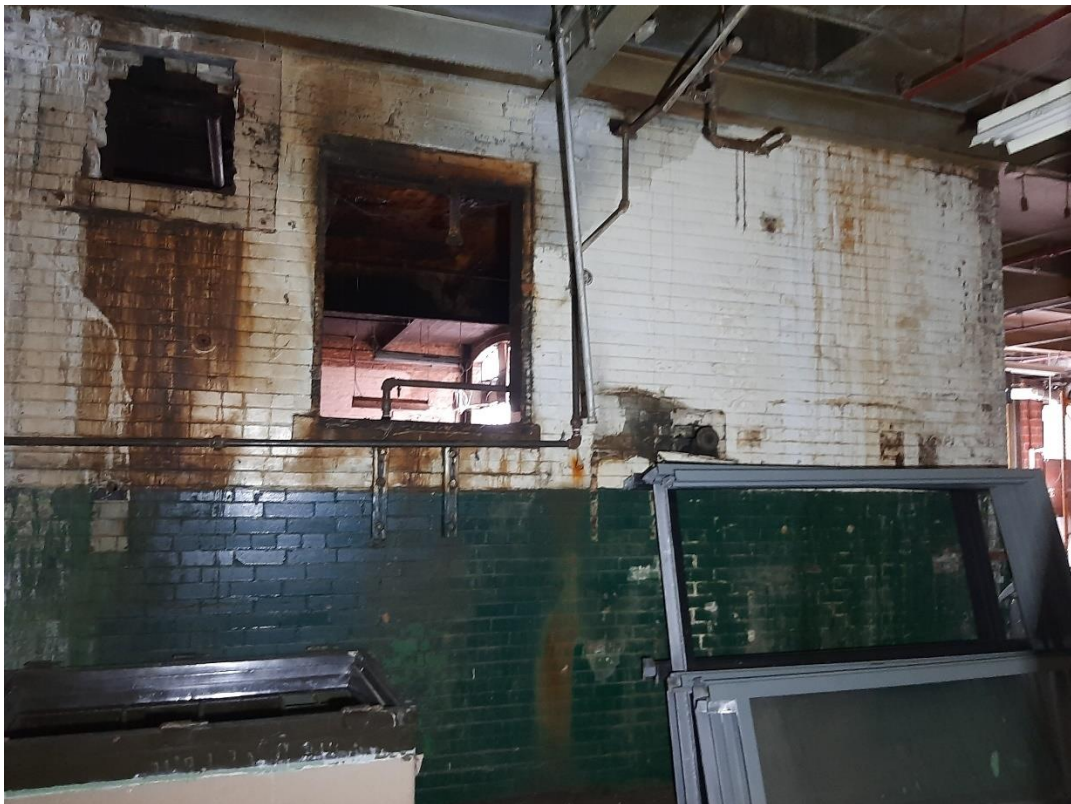
Photograph No. 24 – Second Floor - Looking North

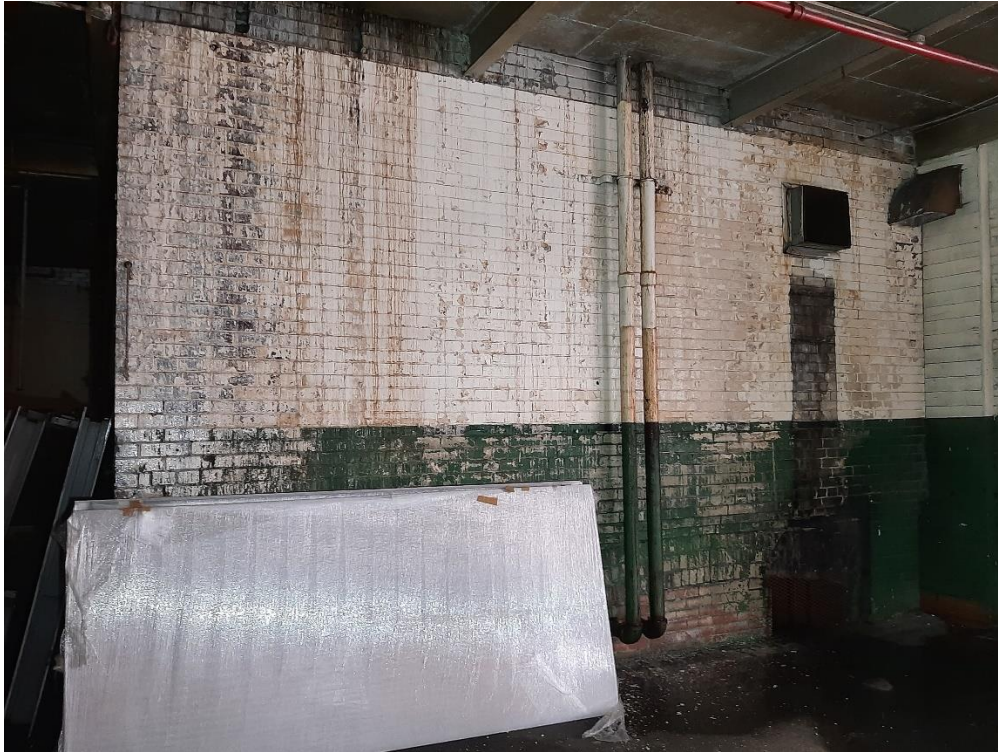
Photograph No. 25 – Second Floor - Looking West

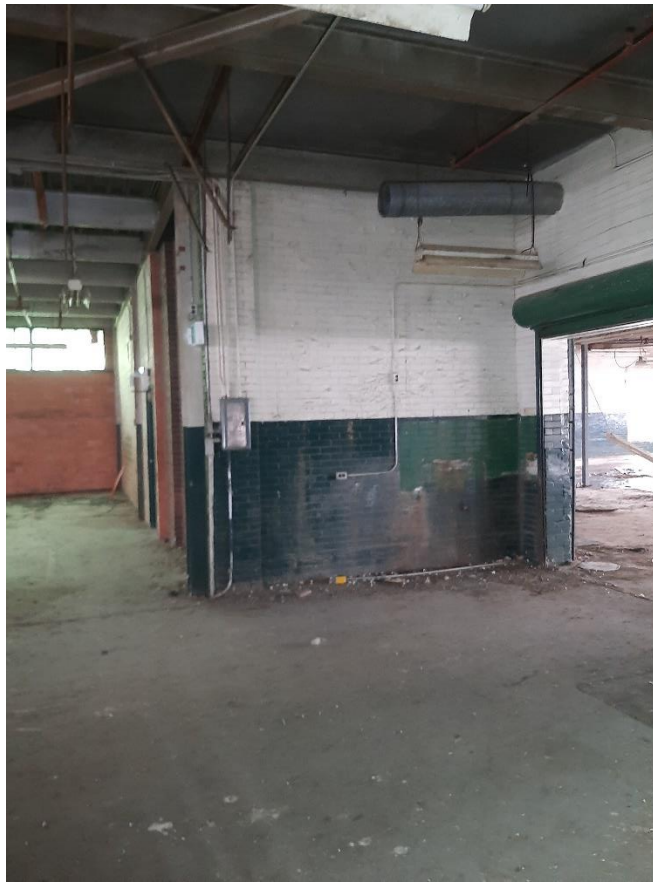
Photograph No. 26 – Second Floor (Looking South) - North wall of Stair

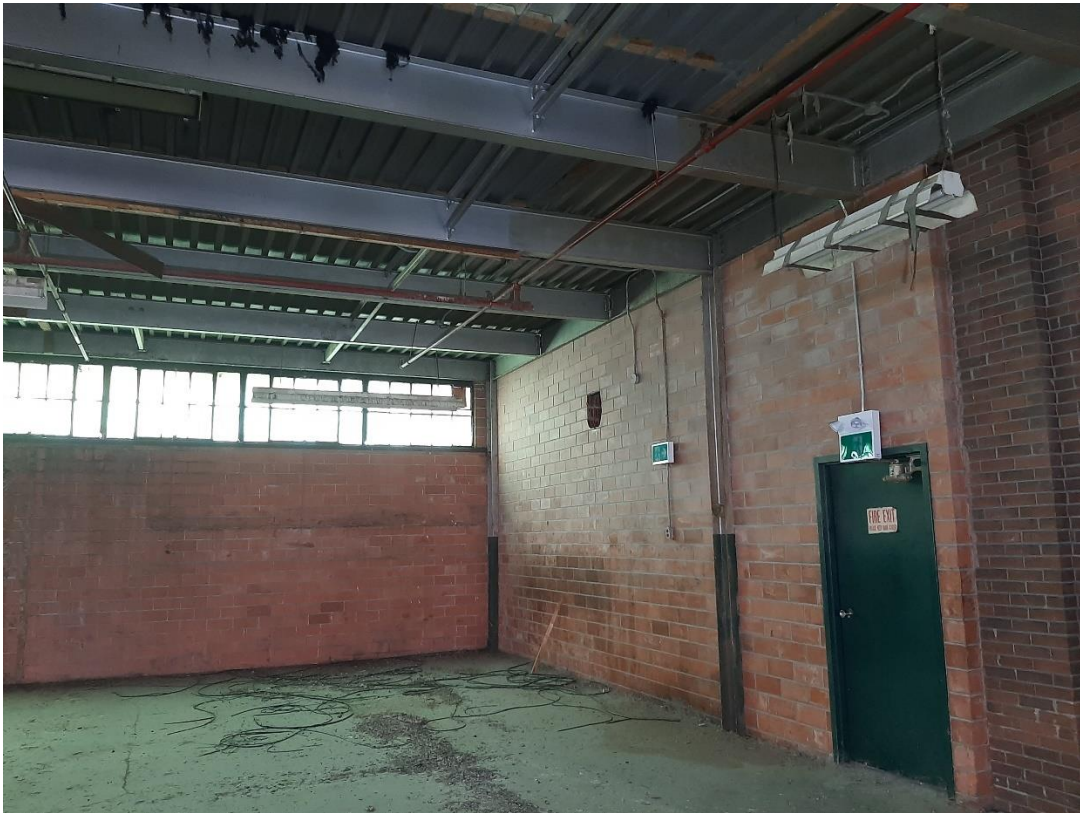
Photograph No. 27 – Second Floor - East Wall of Main Stair

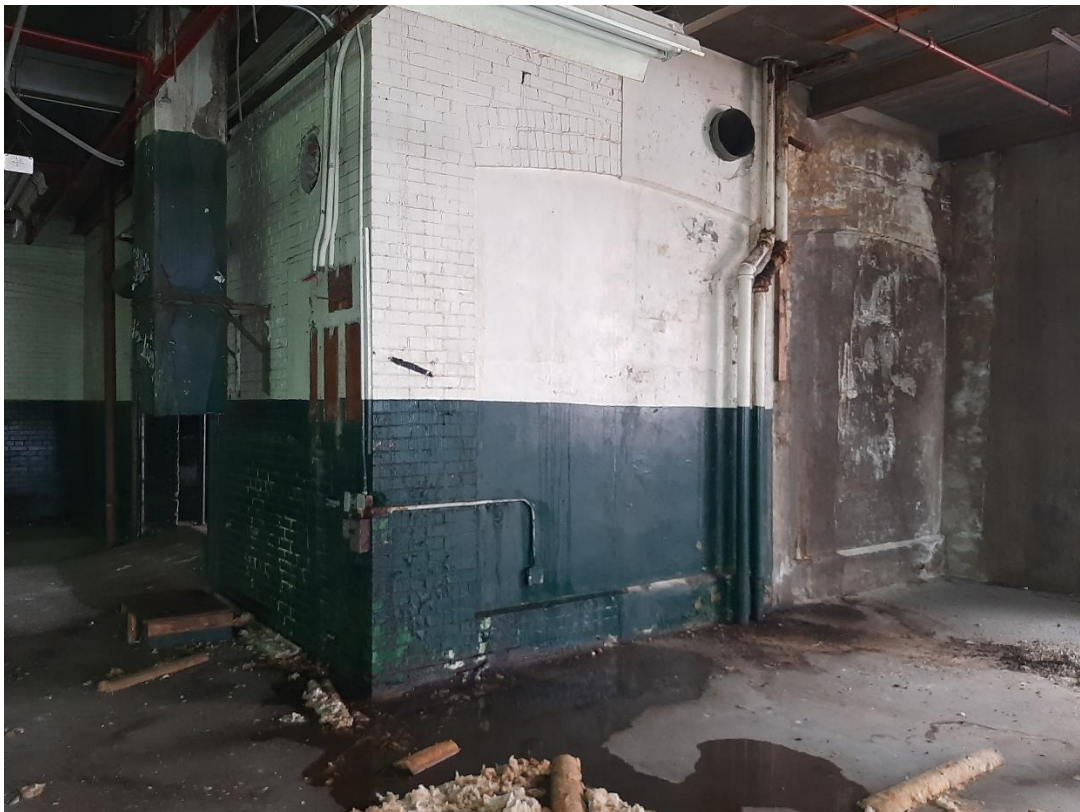
Photograph No. 30 – Third Floor East wall

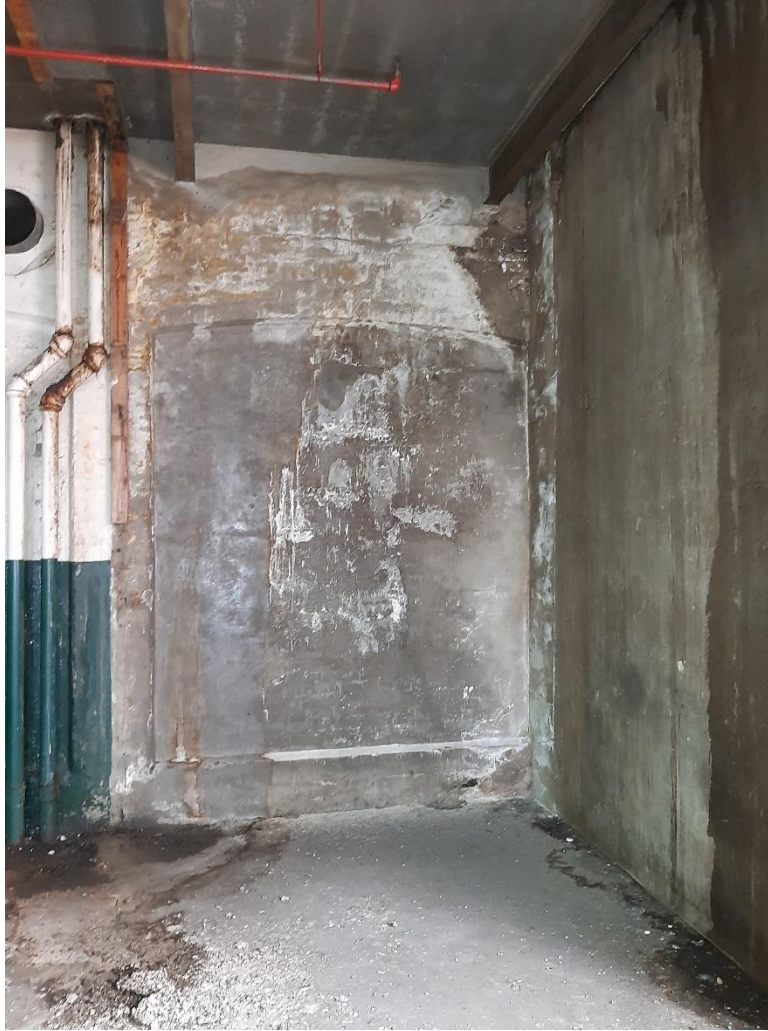
Photograph No. 31 – Third Floor East wall

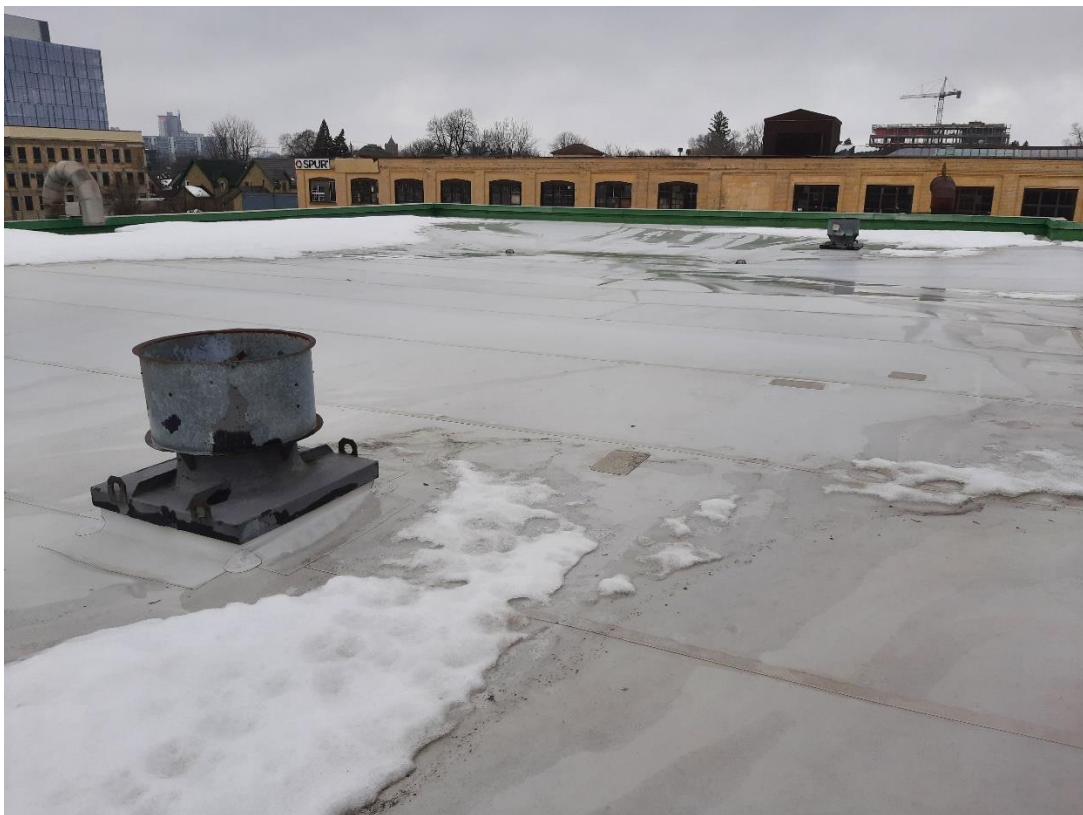
Photograph No. 33 – Roof looking northwest

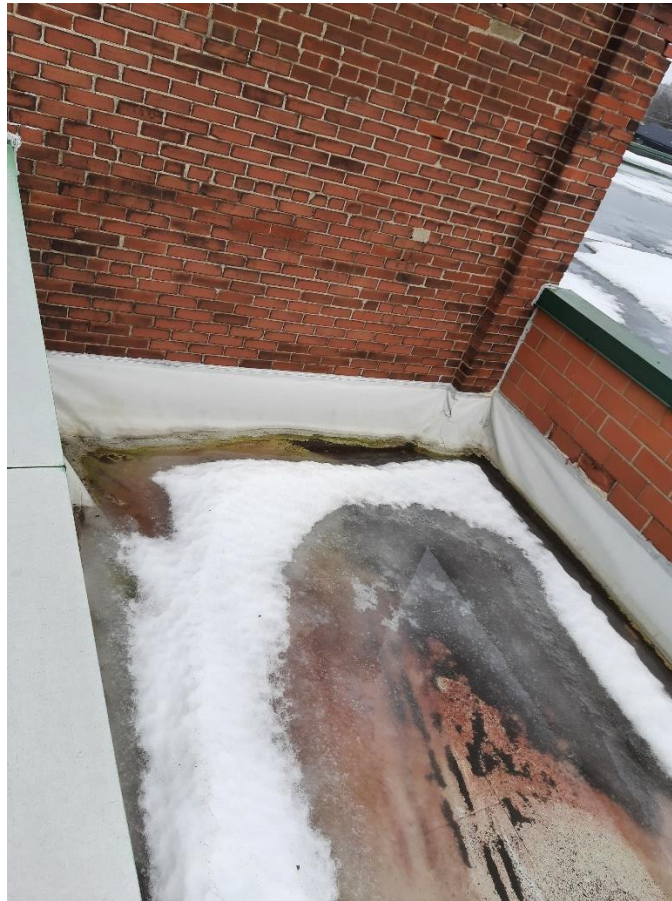
2. Roof is leaking badly through obvious holes in the black EPDM membrane at the 1962 addition near the chimney (Photographs 36-38).
3. Standing water was observed on the main stair roof (Photographs 34,35).

4. Roof EPDM of 1913 building is not well supported at parapets particularly at corners, which could be a leak source (Photographs 34,35). Recommend further investigation by roofing consultant.

Photograph No. 34– Small roof over entrance stair, poor drainage
