60 Victoria Street North, Kitchener

Heritage Conservation Plan

60 Victoria Street North, Kitchener, ON

February 28, 2025

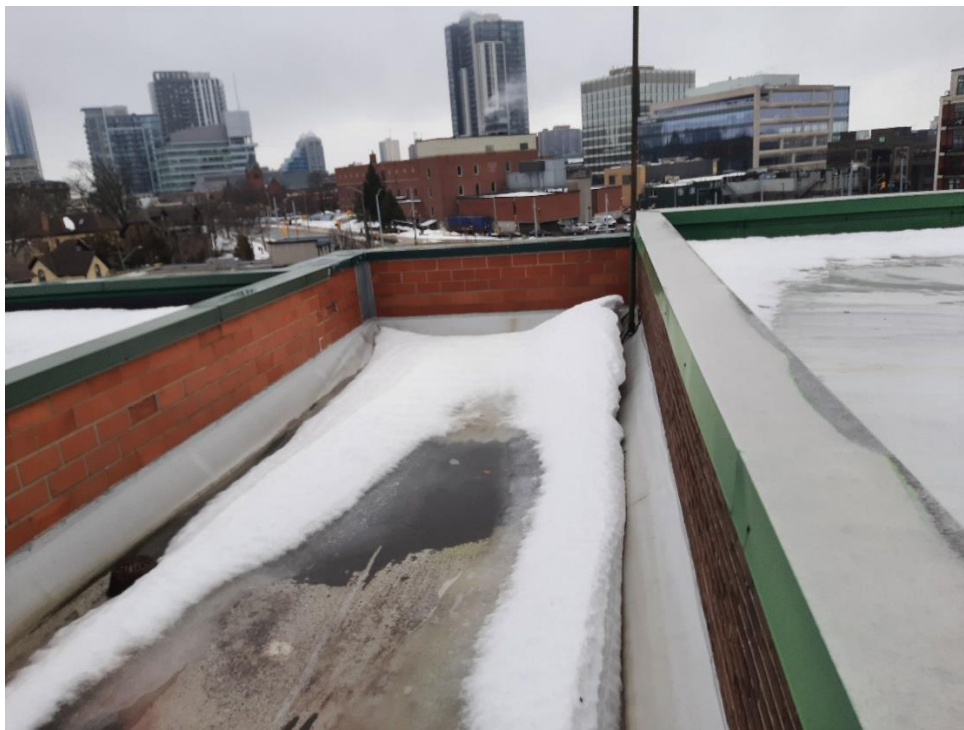
2. Roof is leaking badly through obvious holes in the black EPDM membrane at the 1962 addition near the chimney (Photographs 36-38).
3. Standing water was observed on the main stair roof (Photographs 34,35).

4. Roof EPDM of 1913 building is not well supported at parapets particularly at corners, which could be a leak source (Photographs 34,35). Recommend further investigation by roofing consultant.

Photograph No. 35 – Small roof over entrance stair, poor drainage

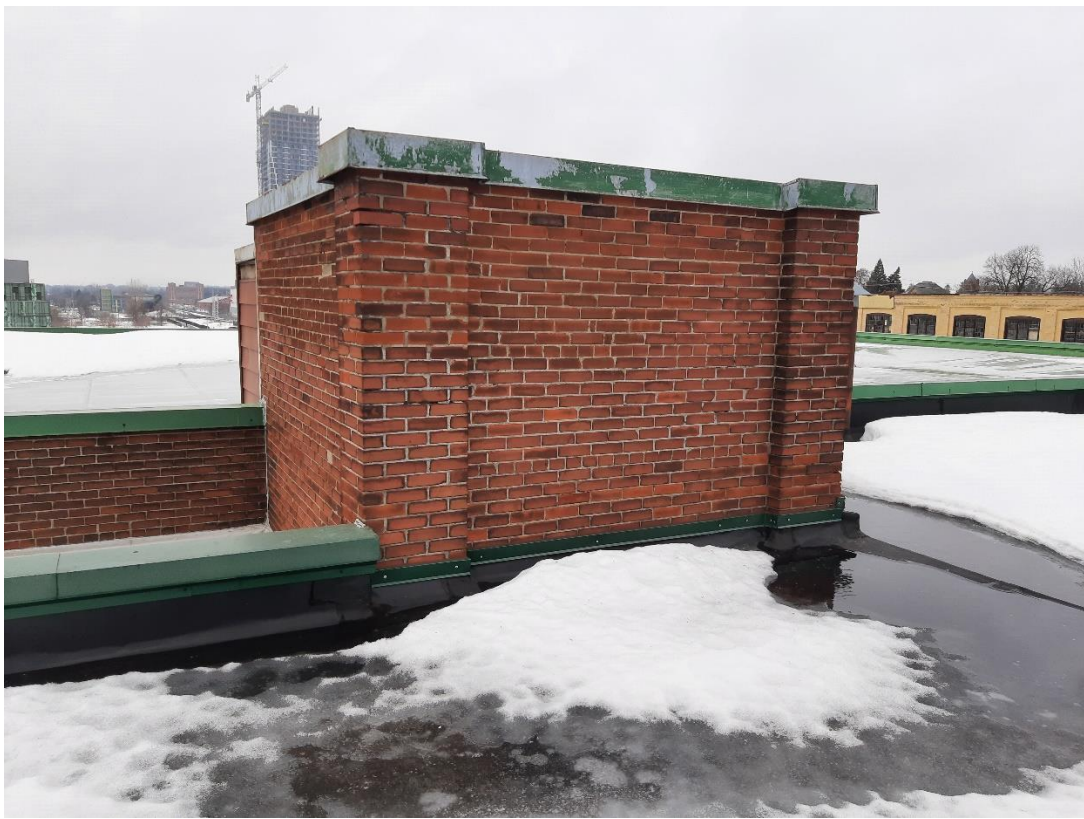
5. Some brick mortar deterioration was observed on the hoist shaft (Photograph 39). Recommend repointing mortar.

Photograph No. 39 – Lift Hoist shaft

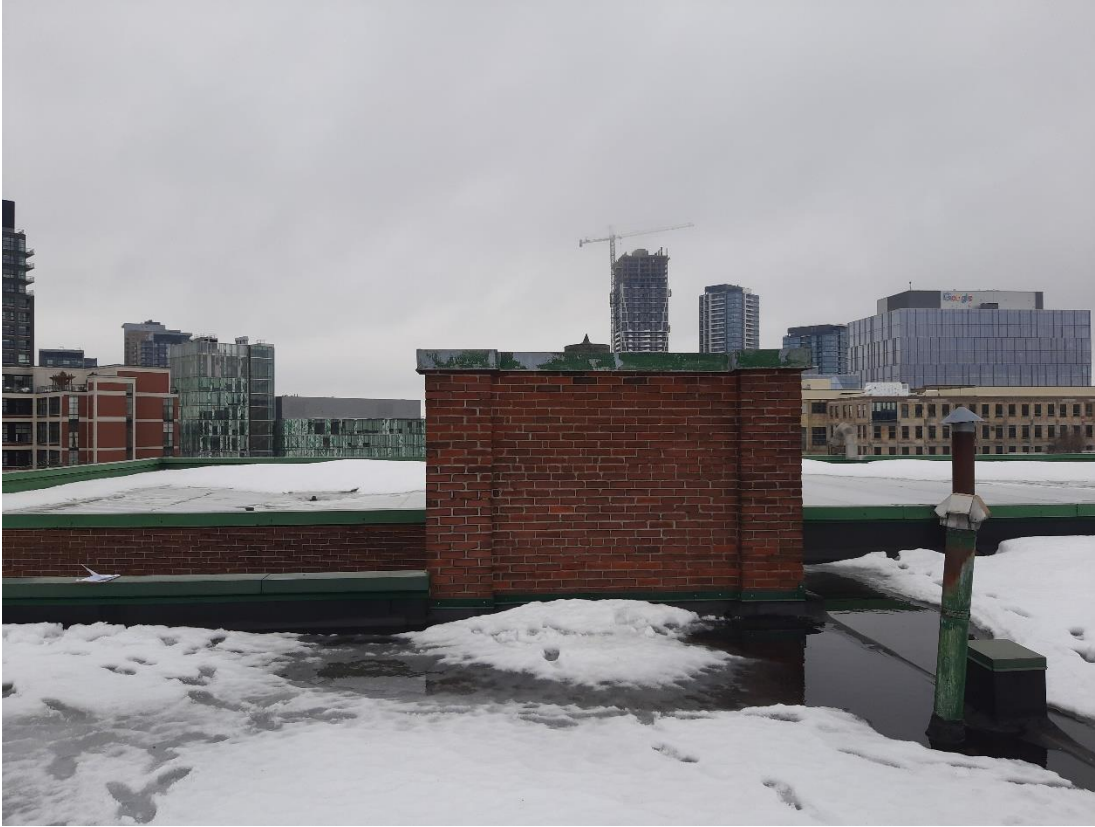
Photograph No. 40 – Looking west

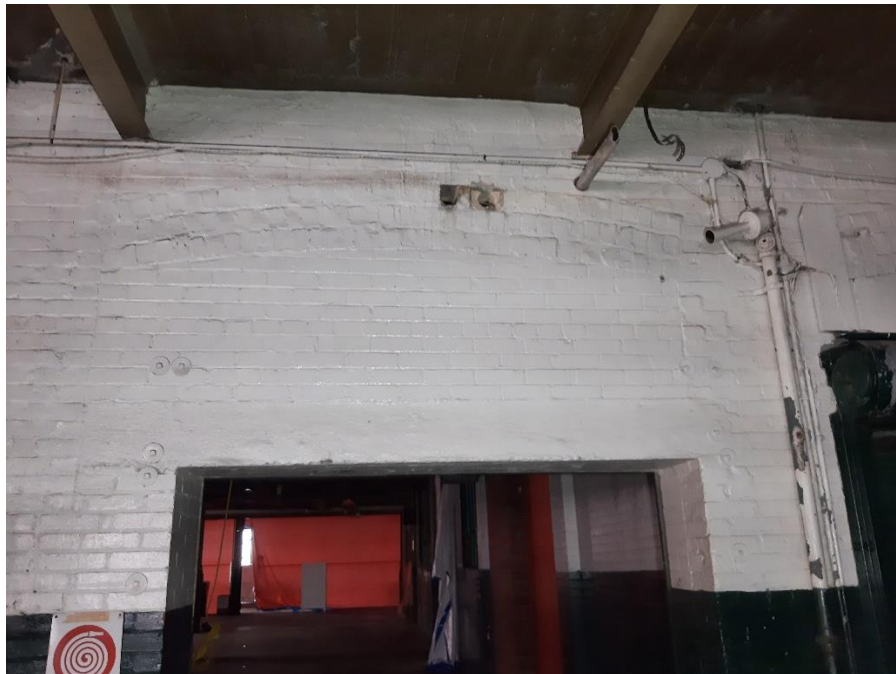
5. Brick is in good condition in stair to third floor (Photograph 51).
6. Doorway and other openings in walls should be infilled as the east wall will become an exterior wall exposed to the elements (Photographs 44,46).

Photograph No. 44 – Ground Floor looking at 1913 East Wall

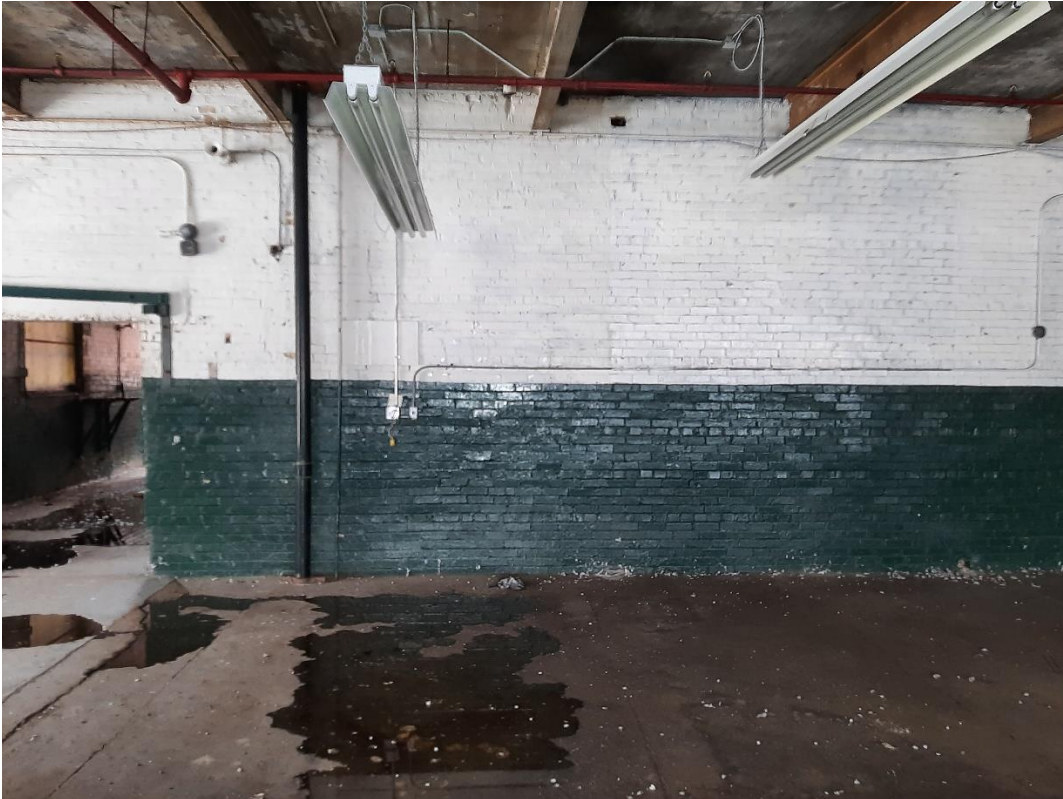
Photograph No. 45 – Ground Floor Looking East

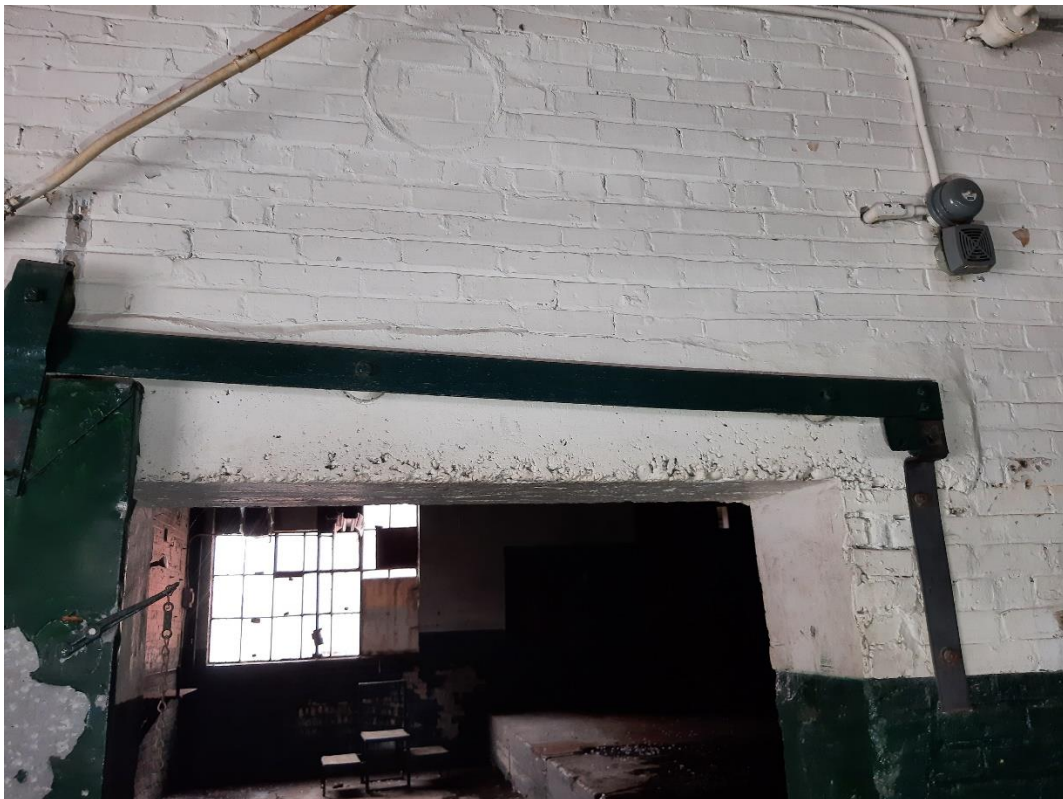
Photograph No. 46 – Ground Floor Looking East, No Distress

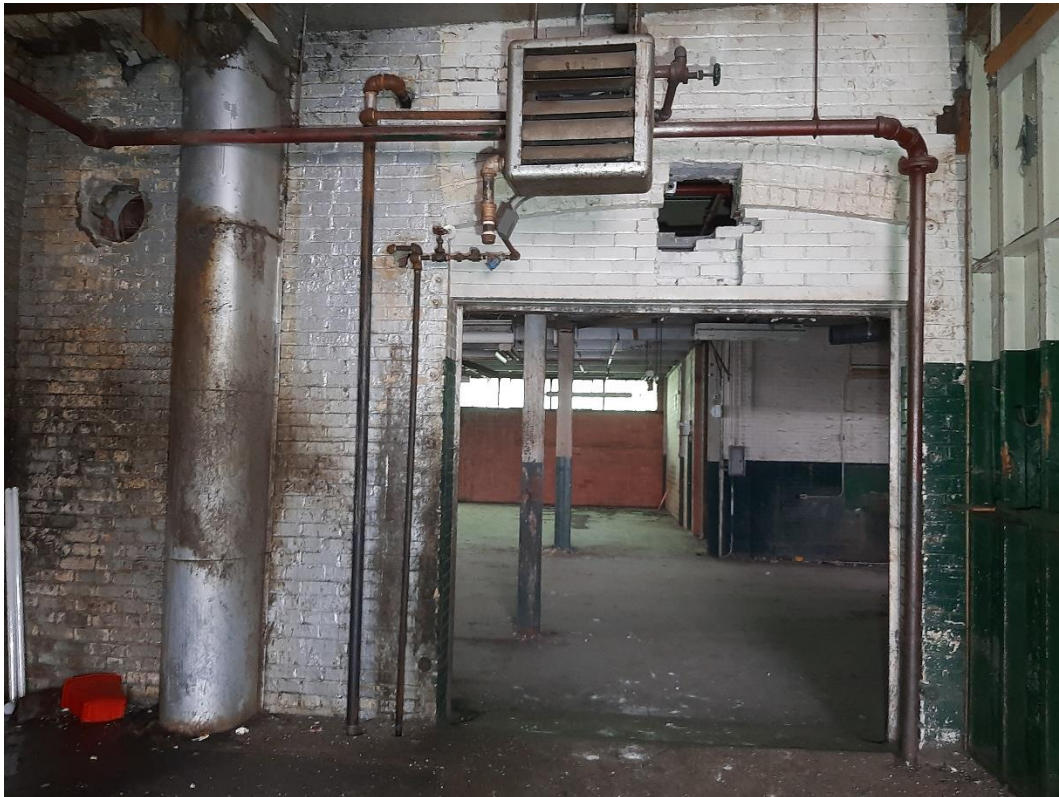
Photograph No. 58 – Third Floor, looking south

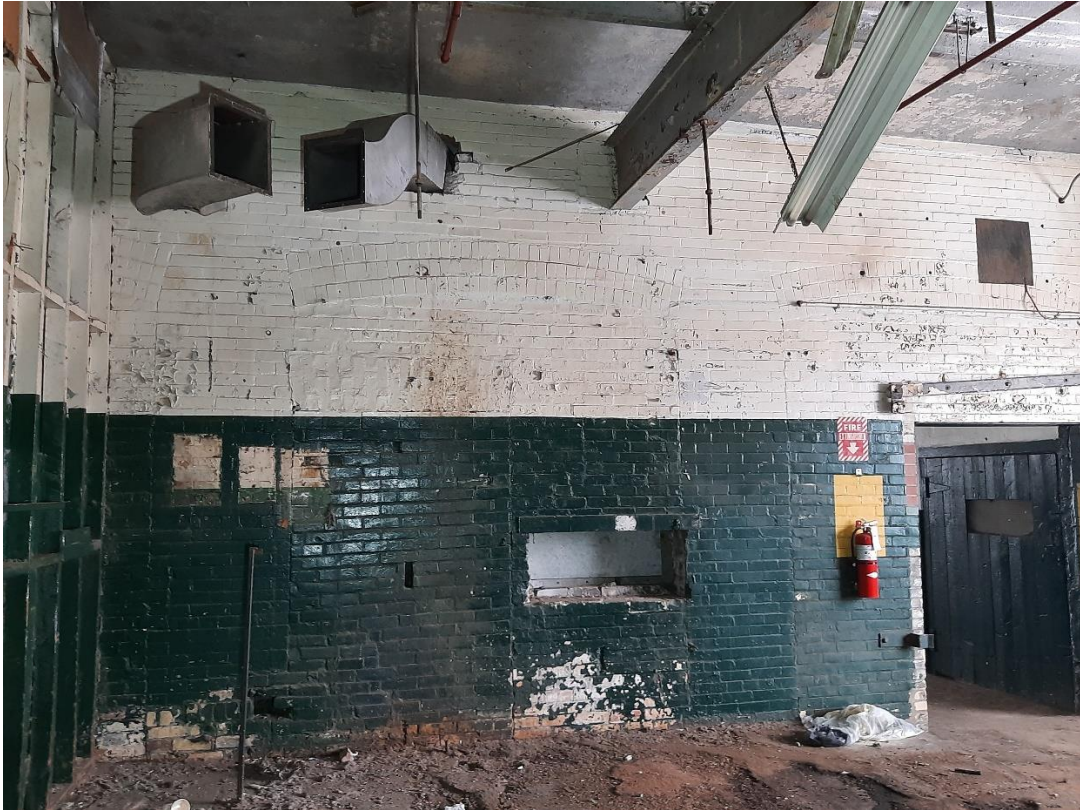
Photograph No. 59 – Third Floor - looking west

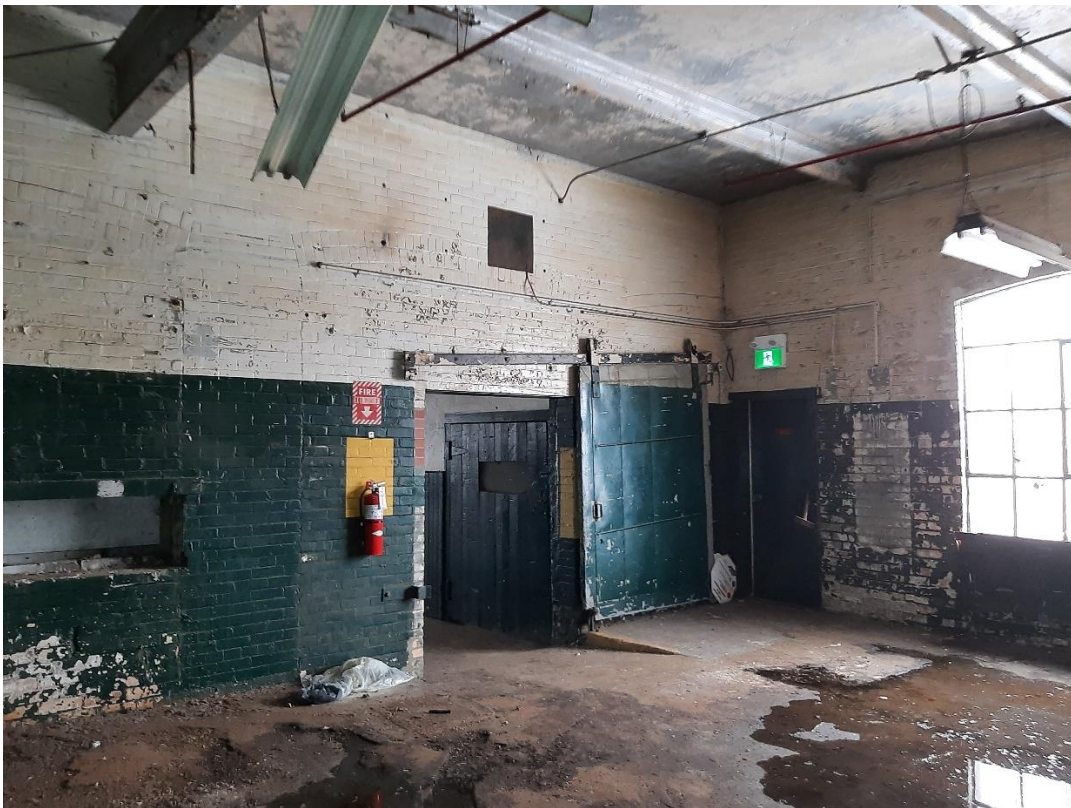
Photograph No. 60 – Third Floor - looking northwest

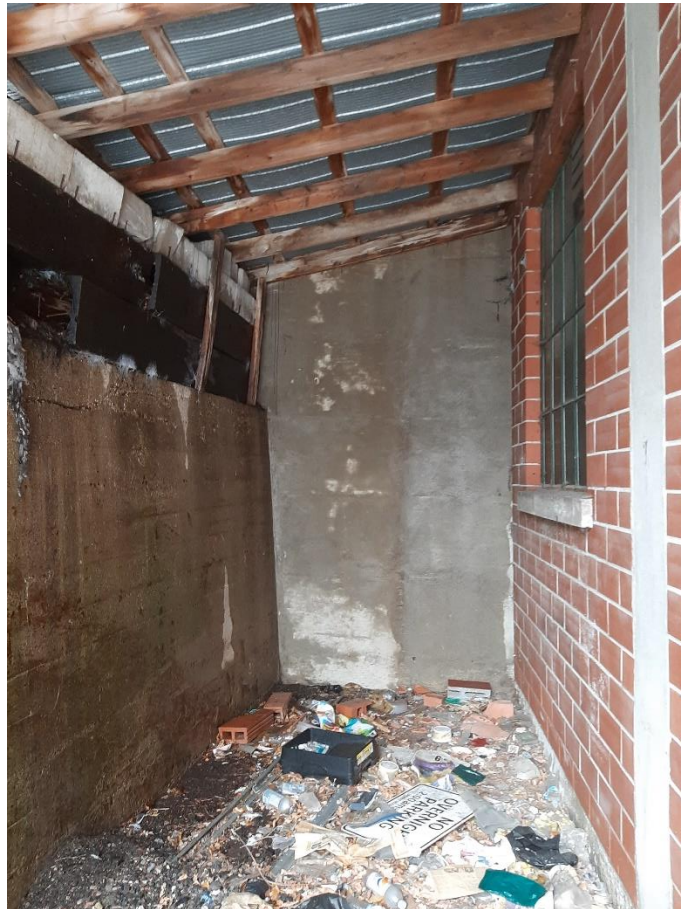
1. Timbers on retaining wall are leaning due to earth pressure, laneway and tree; some timbers are in poor condition; rot observed. Photographs 62-66. Roof shown in Photograph 61 bears on the masonry block and timbers, but ineffectively braces the timbers from leaning. These timbers will need to be restored in alignment and anchorage, and some replaced that have rotted.

Photograph No. 61 – Courtyard looking east

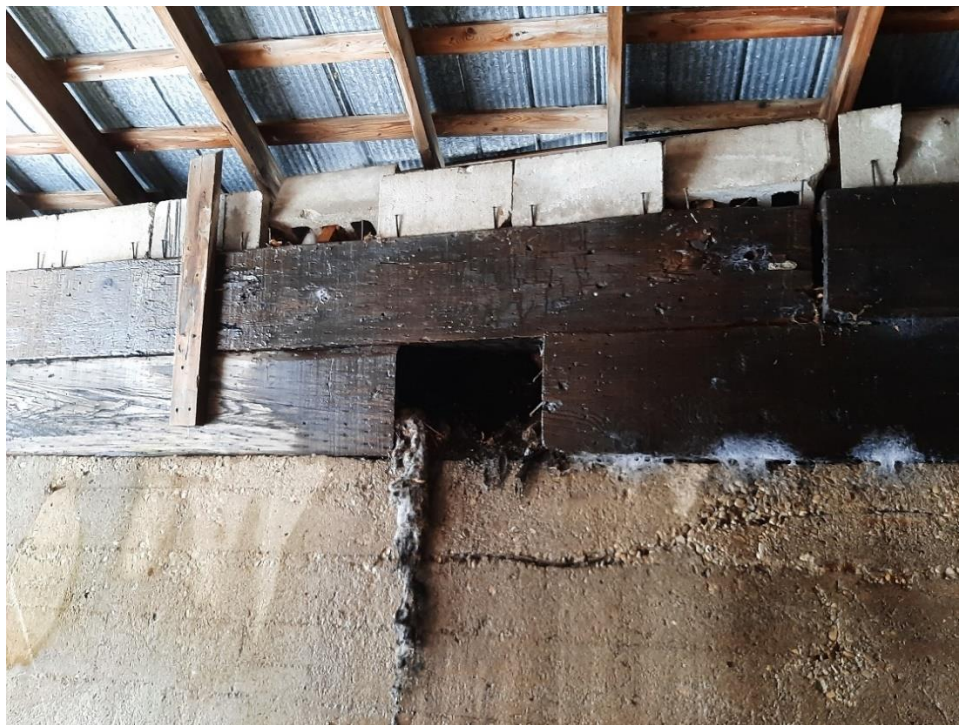
2. Loose laid masonry blocks are on top of the timbers. Only spikes are holding them from falling. Photograph 62.
3. Concrete buttress of retaining wall show signs of deterioration and should be repaired. Photographs 63, 65.

Photograph No. 62 – Courtyard, Timbers leaning, CMU Block at top

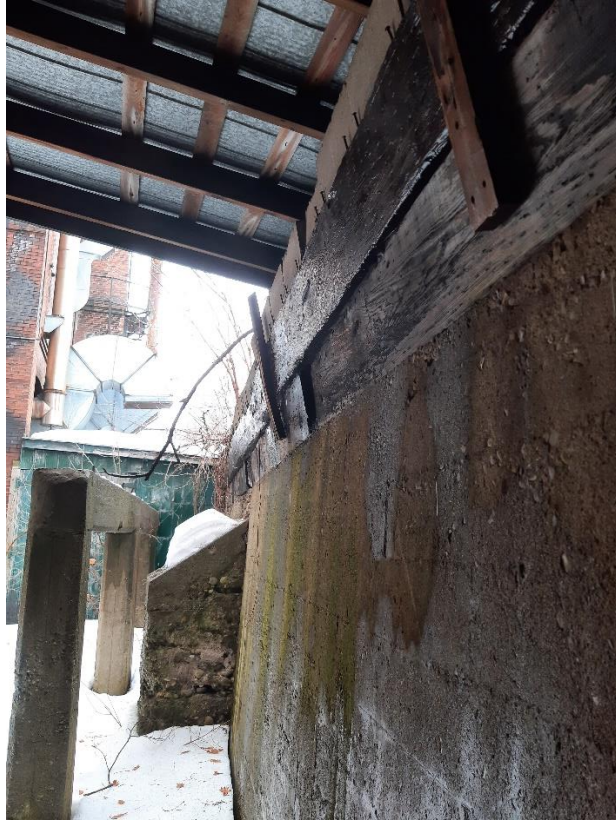
Photograph No. 63 – Courtyard Wall, Looking west, Timbers leaning, Vulnerable CMU Block at top

8. Restore the deteriorated areas of the concrete buttress of the courtyard retaining wall.

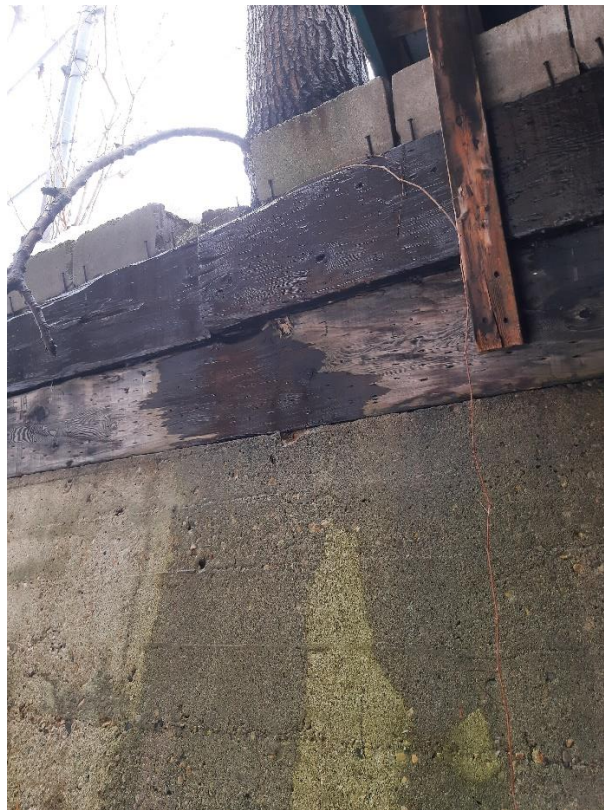
Photograph No. 64 – Courtyard Wall, Timbers leaning, Tree pushing

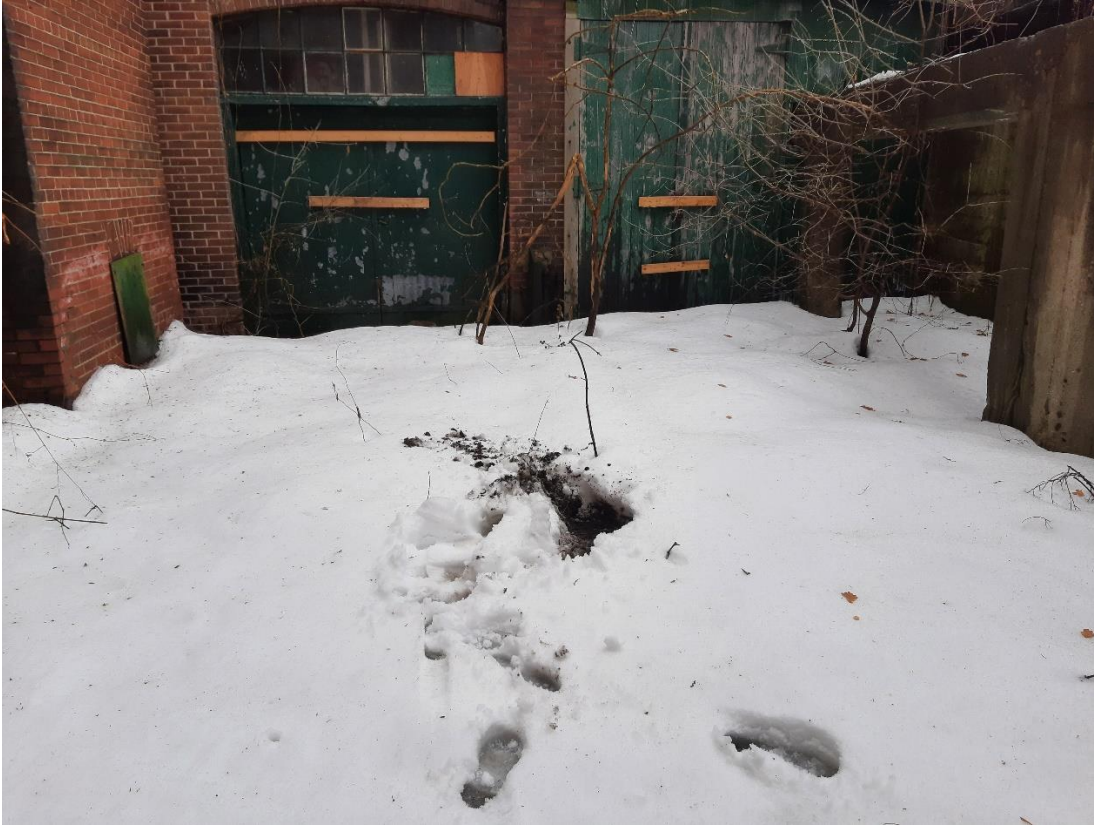
5. Drainage of the courtyard is believed to be natural, through soil infiltration, near center of courtyard. At first exploration, snow was vacant in local hole, likely thought be from heat. Snow was removed (prior to taking Photograph 67), but no catch basin or grate was found.

Photograph No. 67 – Courtyard, drainage in centre
